# Diagnosis report of 2015 MITSUBISHI OUTLANDER Executiv

Diagnosis report of

2015 MITSUBISHI OUTLANDER Executiv

Summary of diagnosed issues

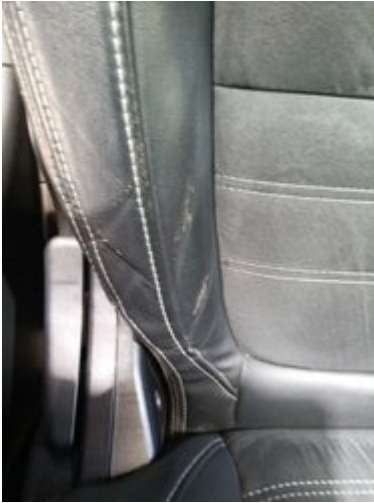
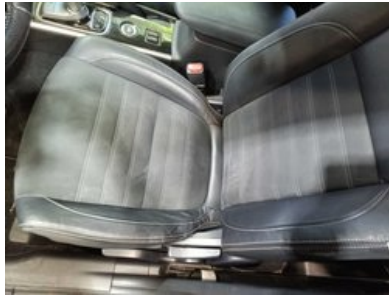
### ✓ 1. Seats: All Seats - Condition

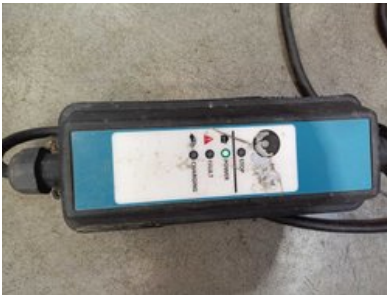
### ✓ 2. Inside: Accessories - Functioning and Condition

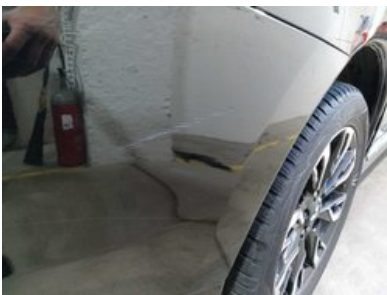
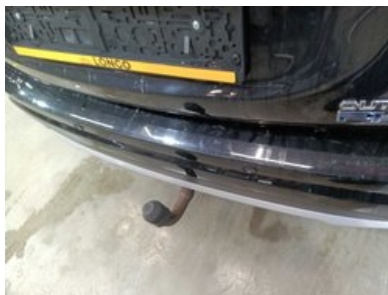
### ✓ 1. Other: Additional Polishing Tasks

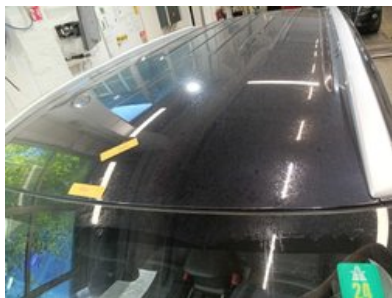
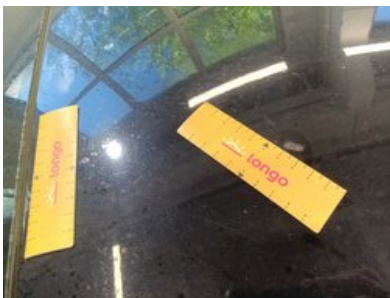
✓ **2. Other:** Roof - Visual Damage (e.g., Hail Damage)

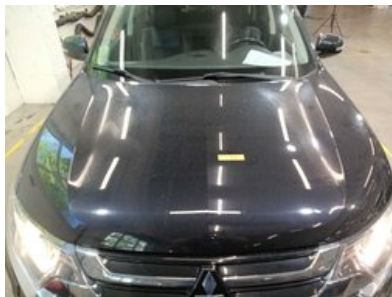
✓ **3. Front:** Hood - Visual Damage

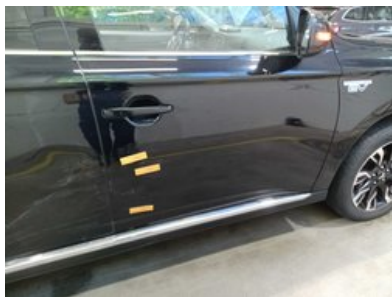
✓ **4. Side:** Left and Right Side - Visual Damage and Scratches

- ✓ 1. Paint Door
- ✓ 2. Paint Rear Fender
- ✓ 3. Paint Sill

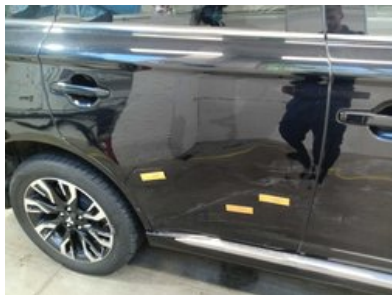
✓ **5. Side:** Left and Right Side - Visual Damage and Scratches

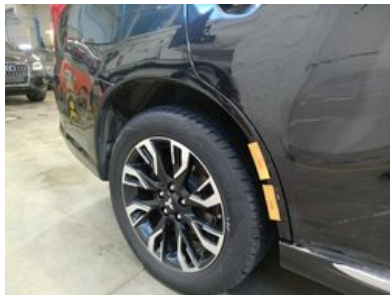
✓ **6. Side:** Left and Right Side - Visual Damage and Scratches

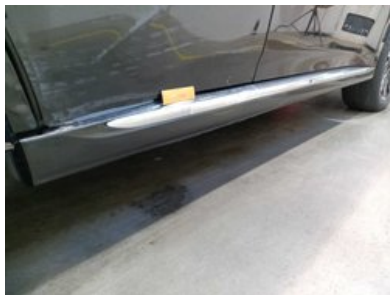
✓ **7. Side:** Left and Right Side - Visual Damage and Scratches

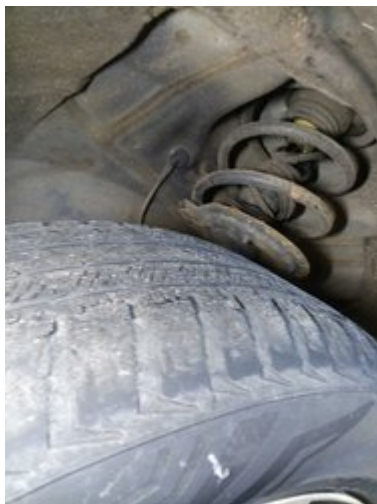
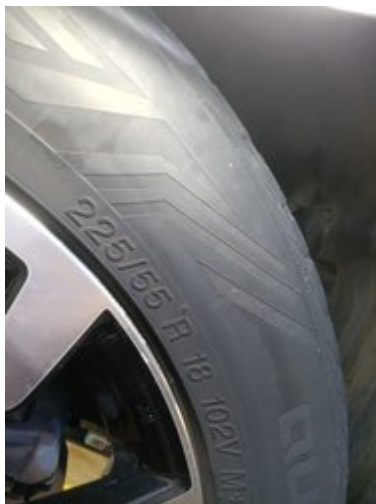
✓ **2. OTHER:** Change Tires

- ✓ 1. Front Wheel Alignment (Toe)
- ✓ 2. Change Tires
- ✓ 3. Track Rod End Joint (Both)
- ✓ 4. Engine Oil & Filter Change

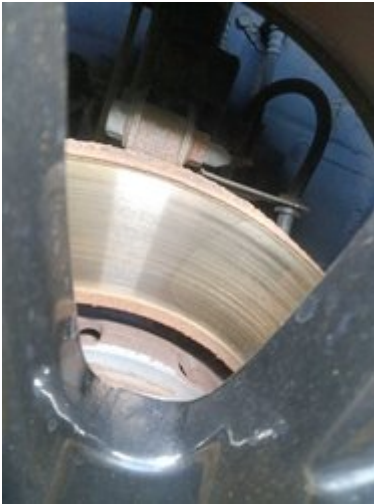
✓ **3. BRAKES:** Front Brake Discs Both with Pads

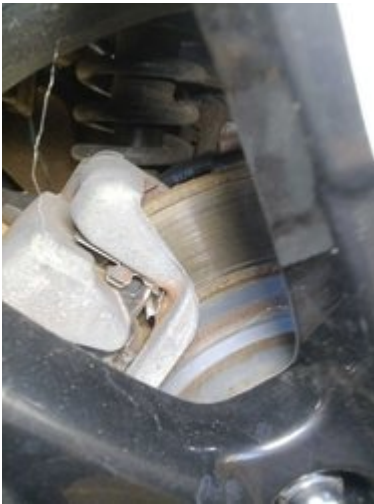
✓ **4. BRAKES:** Rear Brake Disc (Both) with Pads

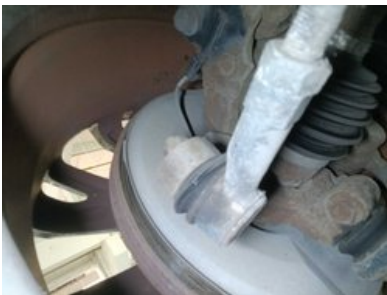
✓ **6. STEERING:** Track Rod End Joint (Both)

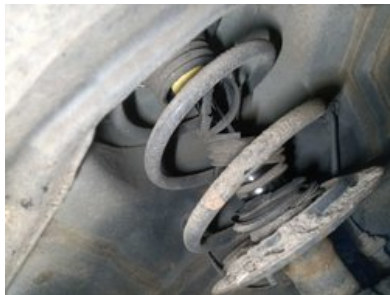
✓ **7. SUSPENSION:** Strut Top Mounting (Both)
