# Diagnosis report of 2016 VOLKSWAGEN GOLF SPORTSVAN

Diagnosis report of

2016 VOLKSWAGEN GOLF SPORTSVAN

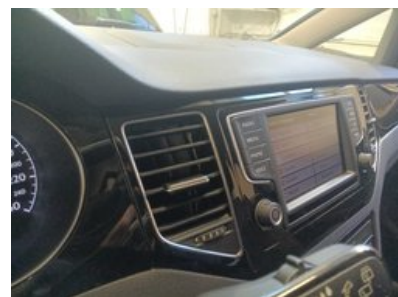
- ✔ 1. Inside: Trims - Condition

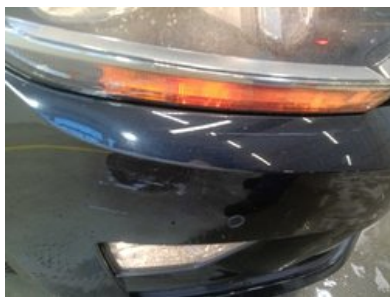
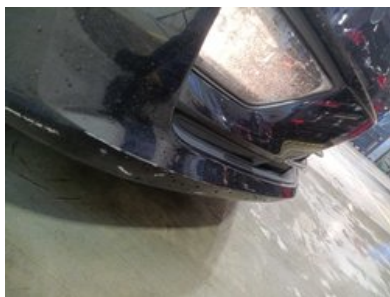
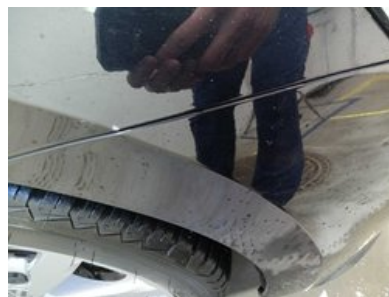
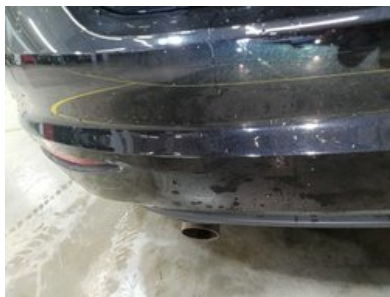
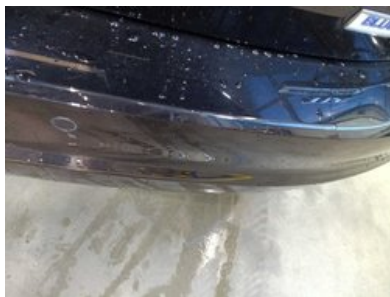
### ✓ 1. Other: Additional Polishing Tasks

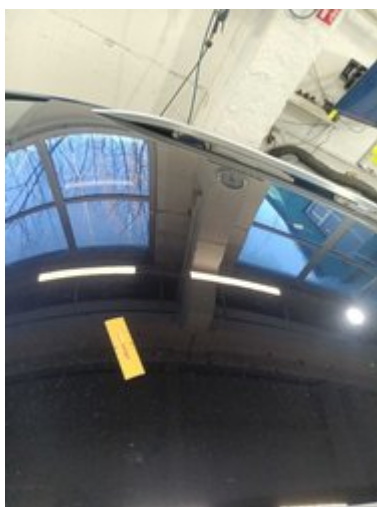
### ✓ 3. Other: Roof - Visual Damage (e.g., Hail Damage)

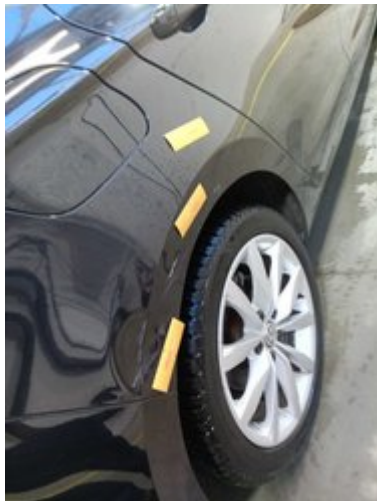
✓ **4. Side:** Left and Right Side - Visual Damage and Scratches

- ✓ 1. Paint Rear Fender

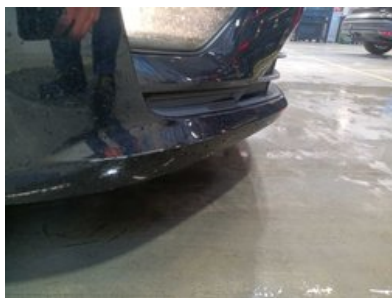
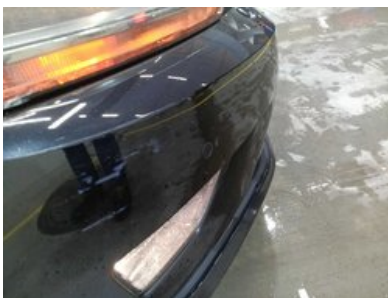
✓ **5. Front:** Front Bumper - Condition and Alignment

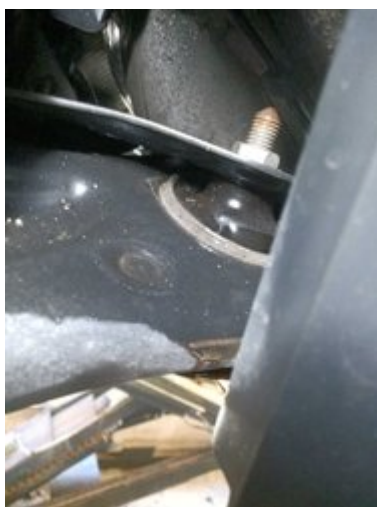
✓ **3. SUSPENSION:** Suspension Lower Arm Rear Bush
