# Diagnosis report of 2015 MITSUBISHI OUTLANDER Business

Diagnosis report of

2015 MITSUBISHI OUTLANDER Business

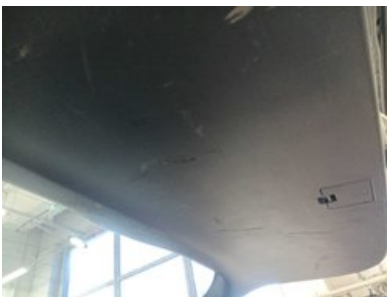
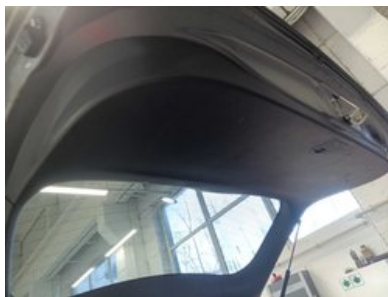
- 
- ✓ **2. Inside:** Trims - Condition

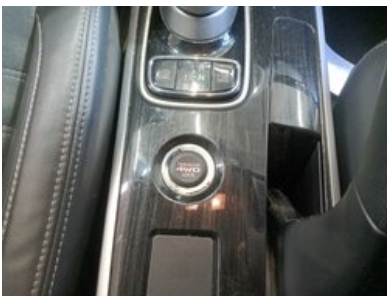
- 
- ✓ **3. Inside:** Trims - Condition

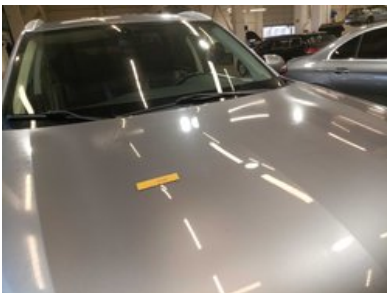
- ✓ **1. Front:** Hood - Visual Damage

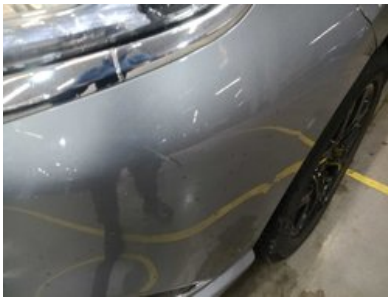
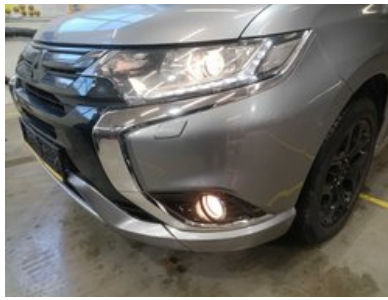
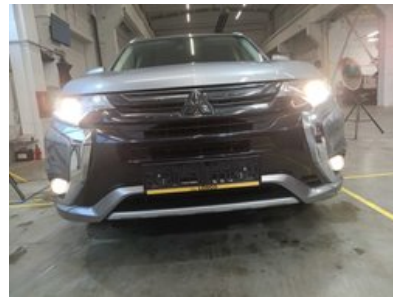
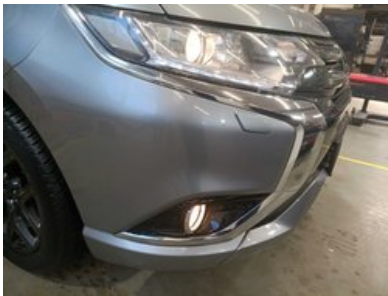
✓ **2. Front:** Front Bumper - Condition and Alignment

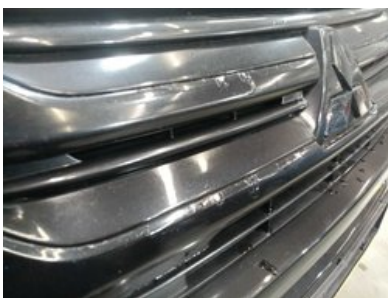
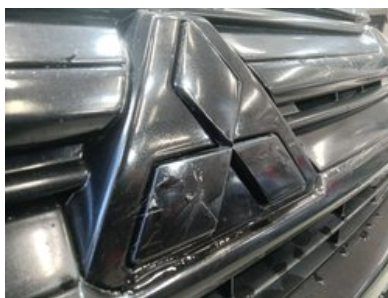
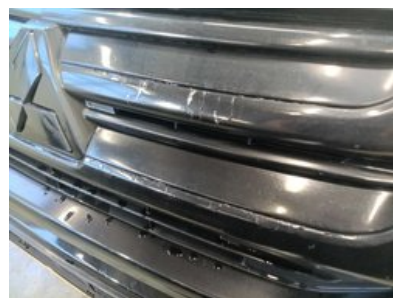
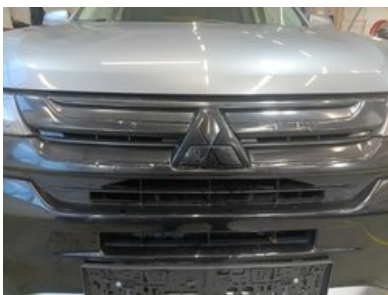
✓ **4. Front:** Front Grille - Condition

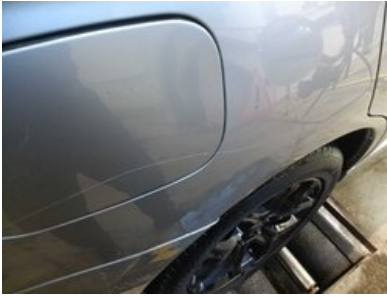
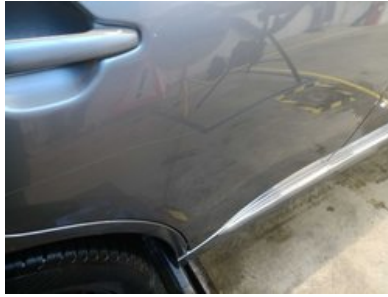
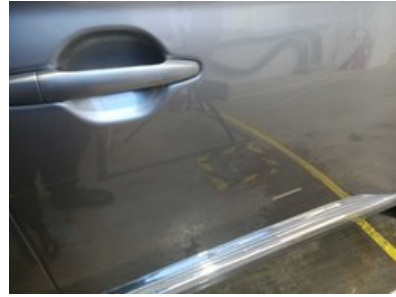
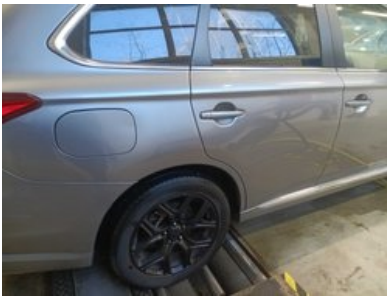
✓ **5. Other:** Additional Polishing Tasks

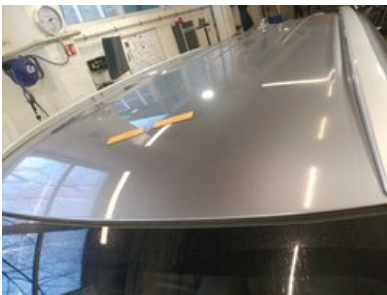
✓ **6. Other:** Roof - Visual Damage (e.g., Hail Damage)

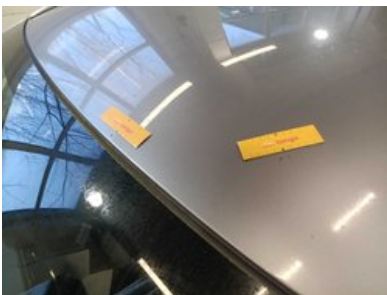
✓ **7. Other:** Roof - Visual Damage (e.g., Hail Damage)

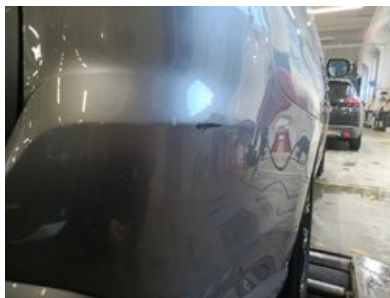
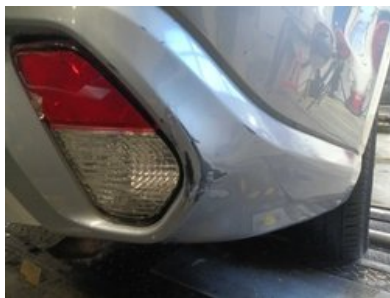
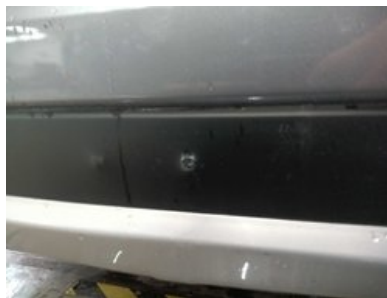
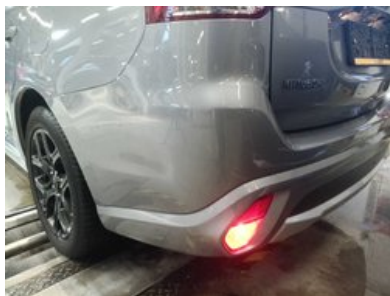
✓ **8. Rear:** Rear Bumper - Condition and Alignment

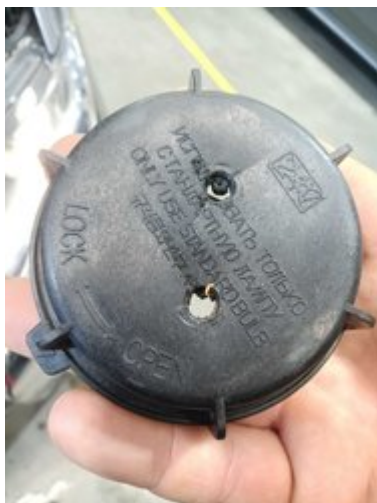
✓ **9. Lights:** Front Lights (City, Regular, Full Headlight, Fog, Indicator) - Basic Functioning, Damage, and Color

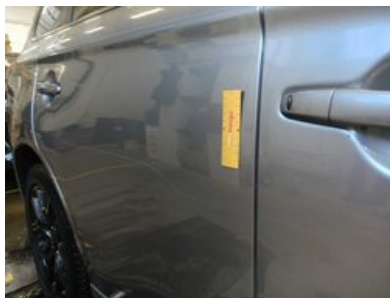
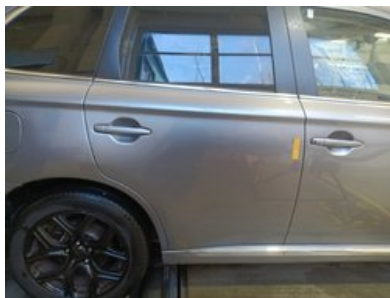
✓ **11. Side:** Left and Right Side - Visual Damage and Scratches

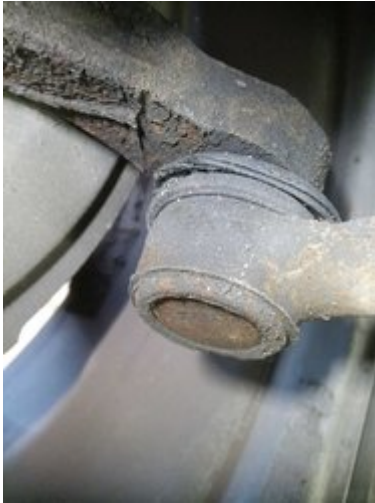
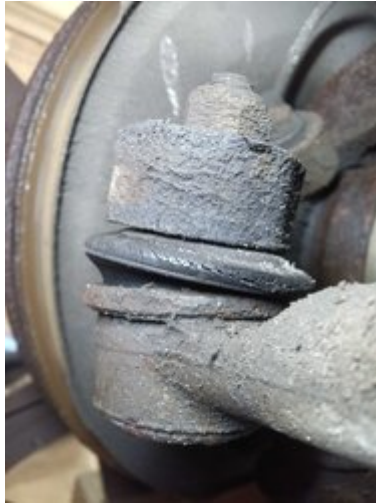
✓ **6. STEERING:** Track Rod End Joint (Both)

- ✓ 1. Track Rod End Joint (Both)
- ✓ 2. Engine Oil & Filter Change
- ✓ 3. Charge Battery
- ✓ 4. Change Light Covers
- ✓ 5. Front Wheel Alignment (Toe)

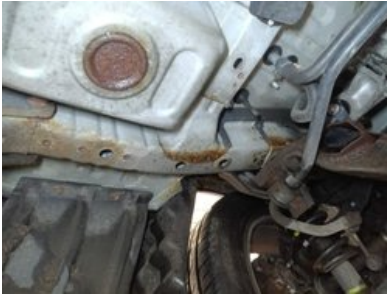
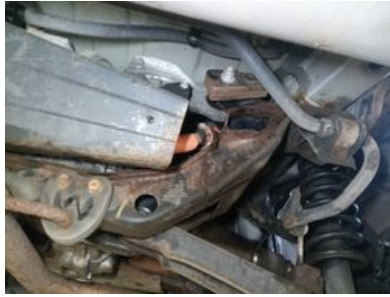
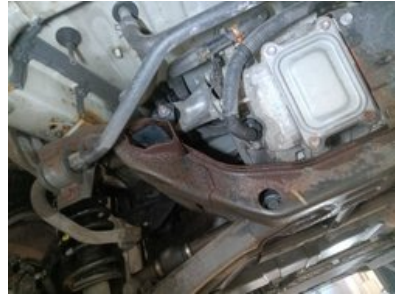
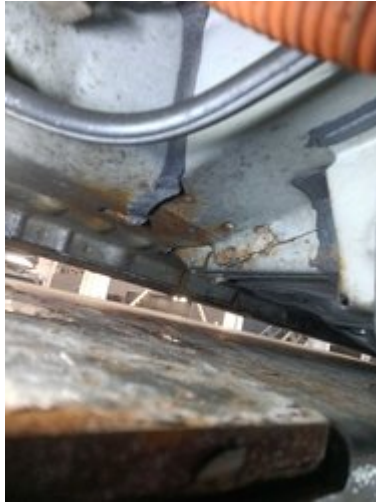
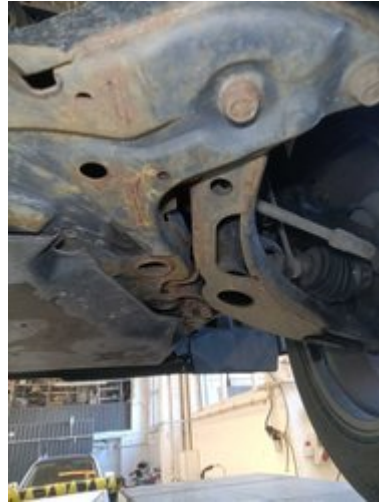
✓ 7. BODY - REAR SECTION: Corrosion
