# Diagnosis report of 2016 HYUNDAI TUCSON Executive

During the comprehensive diagnosis conducted by Longo, 4 issues were identified in the vehicle.

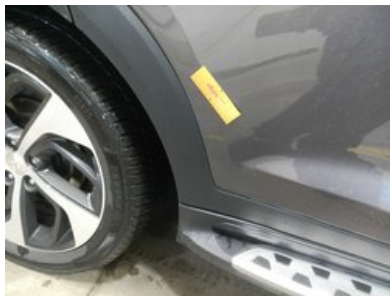
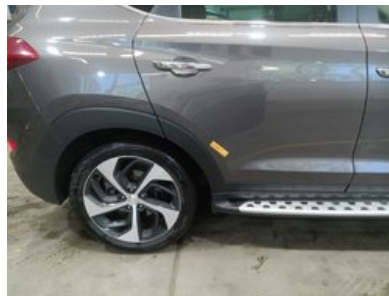
- ✔ **1. Side:** Left and Right Side - Visual Damage and Scratches

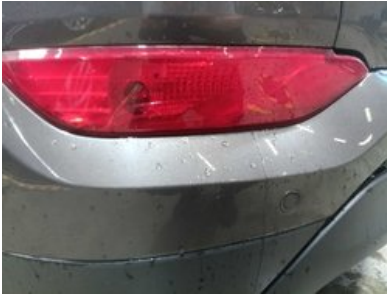
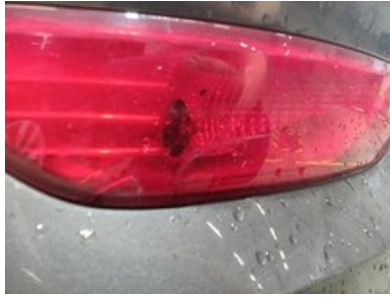
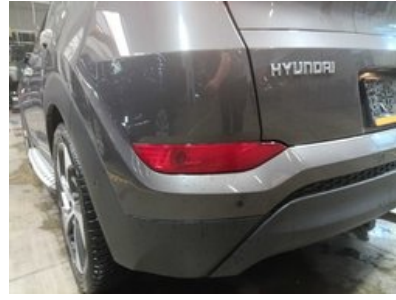
✔ **2. Lights:** Rear Lights (Brake, Fog, Indicator) - Basic Functioning, Damage, and Color

- ✓ 1. Change Rear Lights

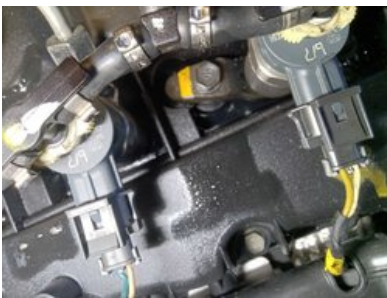
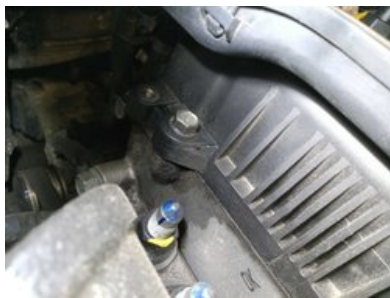
✔ **2. ENGINE:** Camshaft Valve Cover & Gasket

- ✓ 1. Camshaft/Valve Cover & Gasket
- ✓ 2. Engine Oil & Filter Change
