# Diagnosis report of

## 2015 OPEL ASTRA Blitz

# Diagnosis report of 2015 OPEL ASTRA Blitz

# Preparation and repair report of 2015 OPEL ASTRA Blitz

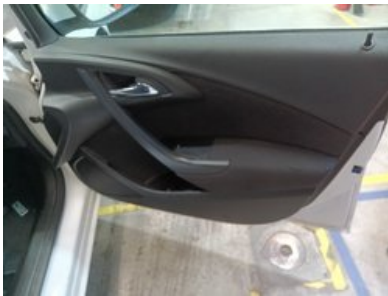
### ✓ 2. Doors: Trims - Condition

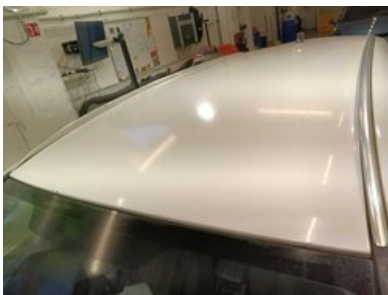
### ✓ 1. Other: Roof - Visual Damage (e.g., Hail Damage)

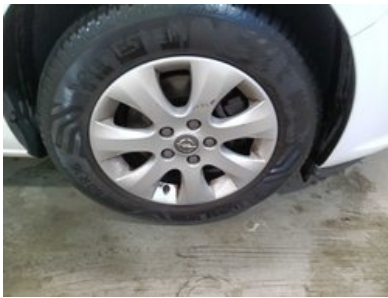
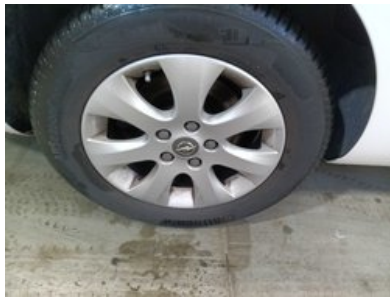
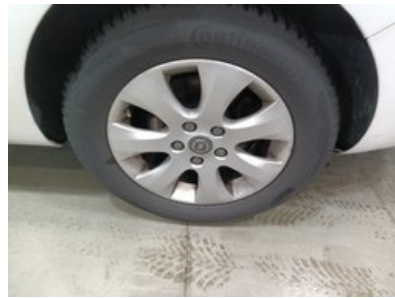
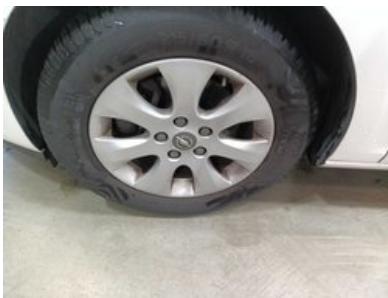
✓ **2. Side:** Wheels - Condition

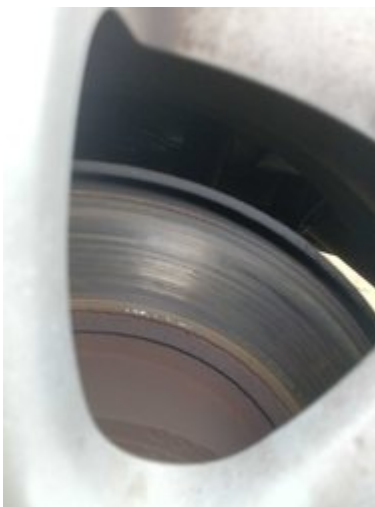
✓ **2. BRAKES:** Rear Brake Disc (Both)

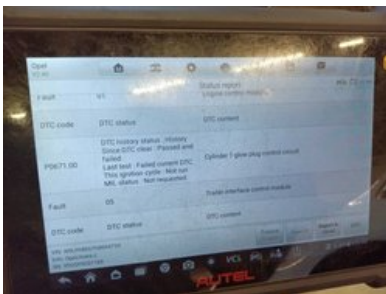
✓ **3. ENGINE:** Glow Plug

- ✓ 1. Engine Oil & Filter Change
- ✓ 2. Glow Plug
