# Diagnosis report of 2020 OPEL INSIGNIA Business Executive

Diagnosis report of

2020 OPEL INSIGNIA Business Executive

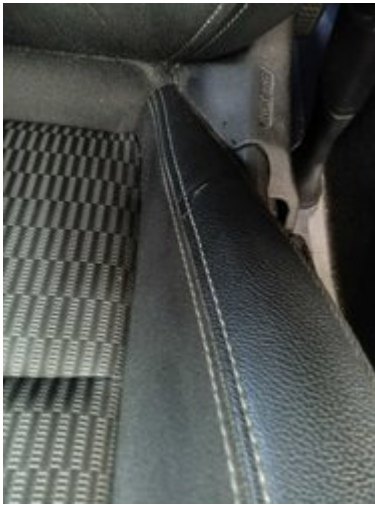
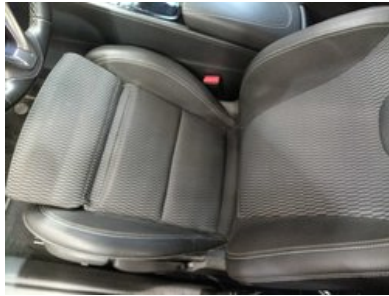
✓ **1. Seats:** All Seats - Condition

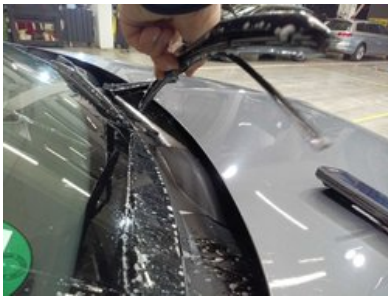
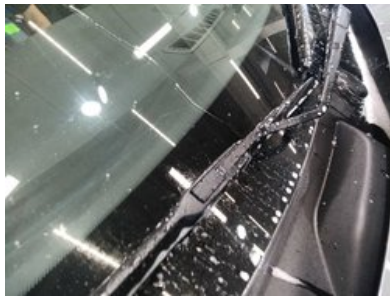
✓ **2. Front:** Window Wiper Rubber and Handle (Front and Rear) - Condition

- ✓ 1. Change Front Wiper (Mechanical)
- ✓ 2. Change Rear Wiper (Mechanical)
- ✓ 3. System Evacuation/Recharging
- ✓ 4. Engine Oil & Filter Change

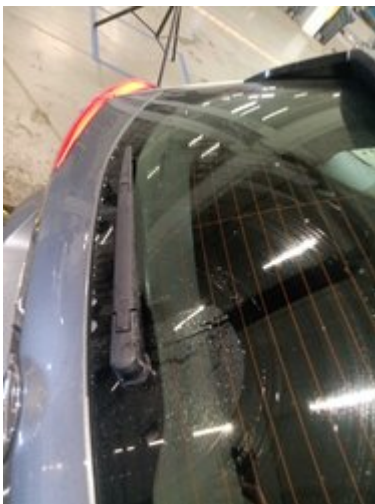
✓ **3. Front:** Window Wiper Rubber and Handle (Front and Rear) - Condition

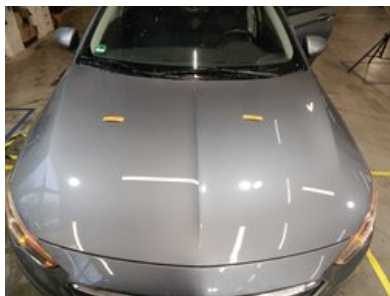
### ✓ 1. Front: Hood - Visual Damage

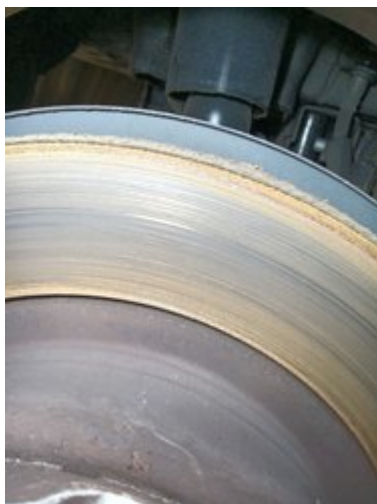
### ✓ 1. BRAKES: Rear Brake Disc (Both)

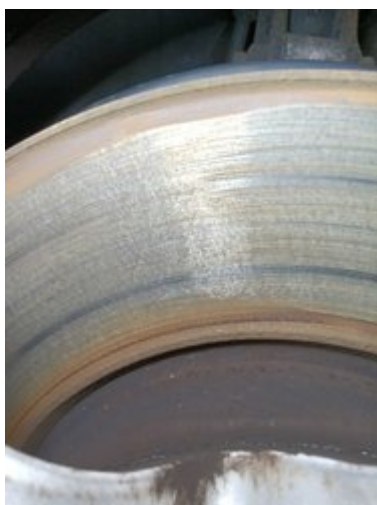
### ✓ 2. BRAKES: Front Brake Discs Both

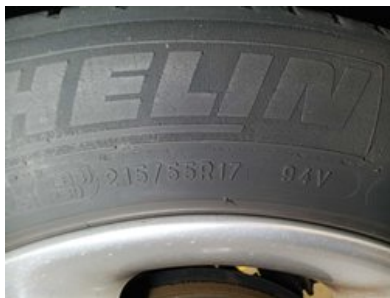
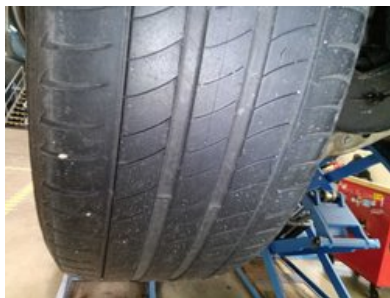
✓ **3. OTHER:** Change Tires
