# Diagnosis report of 2015 CITROEN C4 CACTUS Business Plus

| VIN Code: VF70BBHYBFE568731 | Fuel consumption: 3.10 l/100km |

Diagnosis report of

2015 CITROEN C4 CACTUS Business Plus

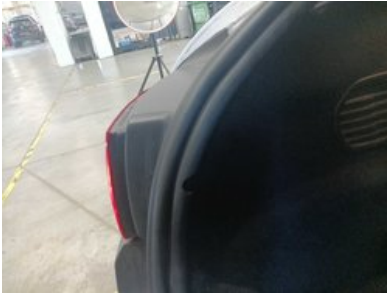
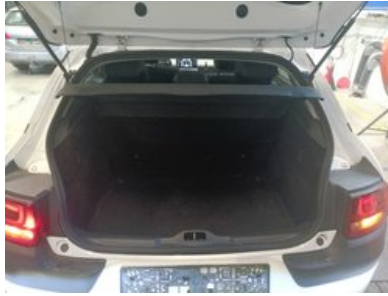
### ✓ 1. Doors: Door Rubber Seals

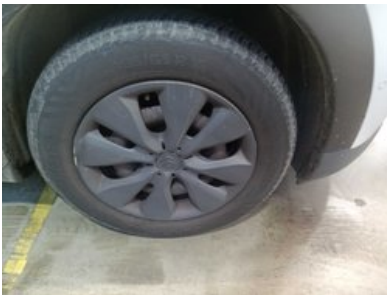
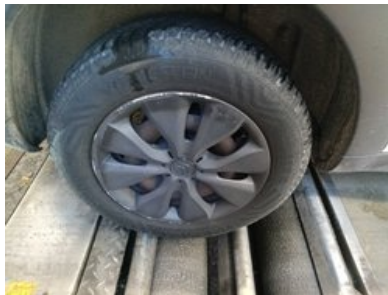
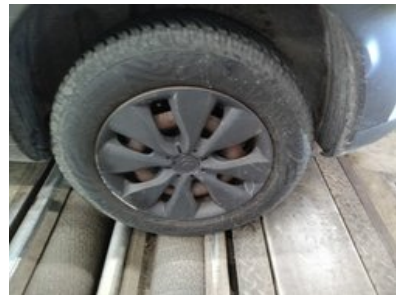
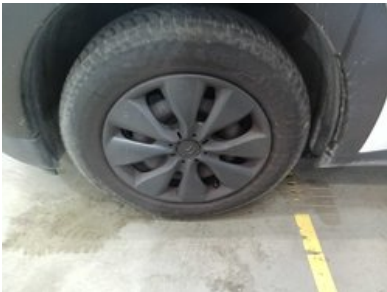
### ✓ 1. Side: Wheels - Condition

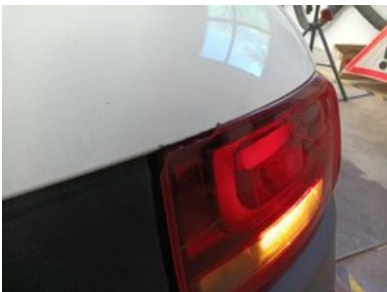
### ✓ 2. Lights: Rear Lights (Brake, Fog, Indicator) - Basic Functioning, Damage, and Color

- ✓ 1. Change Rear Lights

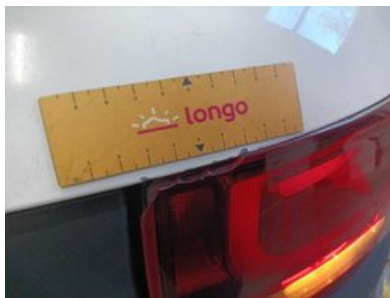
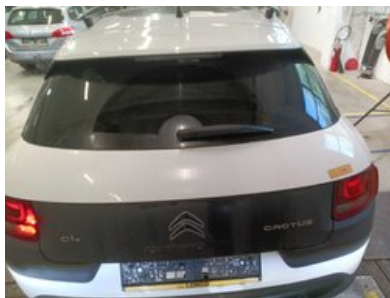
✓ **3. Rear:** Trunk - Visual Damage

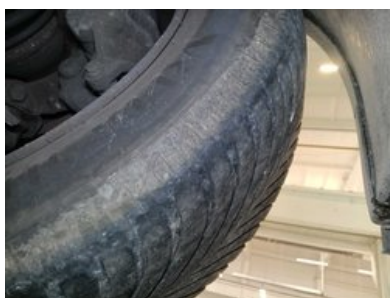
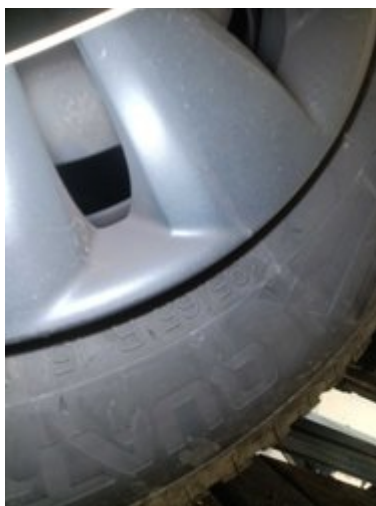
✓ **2. OTHER:** Change Tires

- ✓ 1. Engine Oil & Filter Change
- ✓ 2. Change Tires
