# Diagnosis report of 2019 PEUGEOT 5008 Allure

# Preparation and repair report of 2019 PEUGEOT 5008 Allure

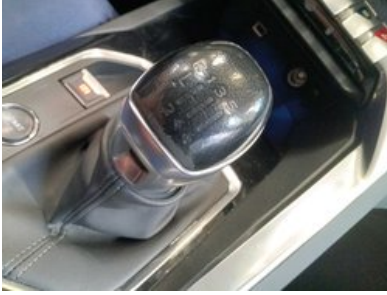
- ✓ **1. Inside:** Gear Shift Boot and Gear Shift Knob - Condition

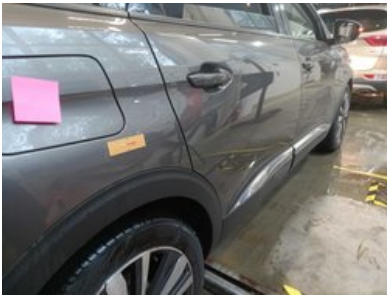
- ✓ **1. Side:** Left and Right Side - Visual Damage and Scratches

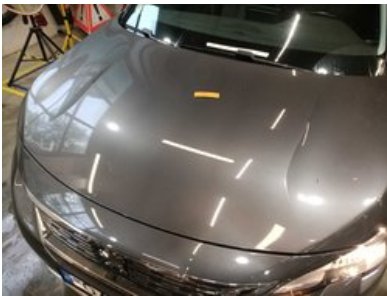
- 
- ✓ **2. Front:** Hood - Visual Damage

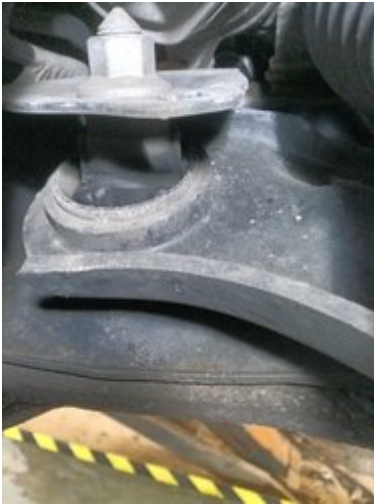
✓ **2. SUSPENSION:** Suspension Lower Arm Bushes Both

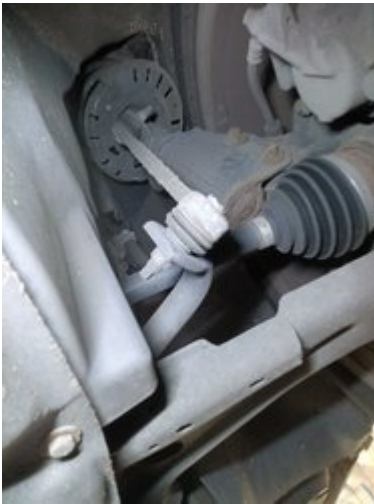
✓ **3. SUSPENSION:** Anti-Roll Bar Link, Outer, Both Sides

- ✓ 1. Anti-Roll Bar Link - Outer (Both)
- ✓ 2. Engine Oil & Filter Change

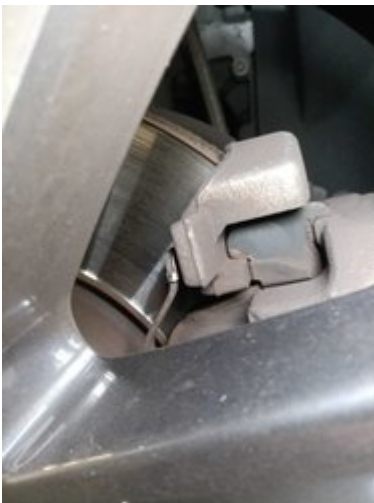
✓ **4. BRAKES:** Front Brake Discs Both
