# Diagnosis report of 2017 FORD KUGA ST Line

During the comprehensive diagnosis conducted by Longo, 11 issues were identified in the vehicle.

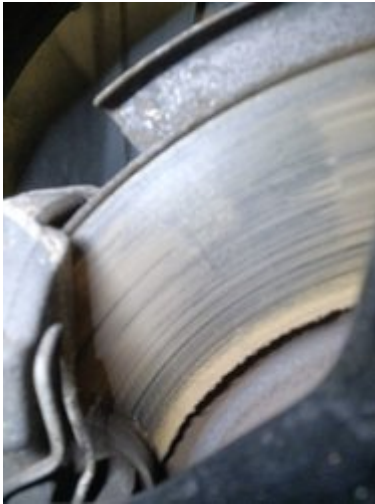
✓ **2. BRAKES:** Front Brake Discs Both

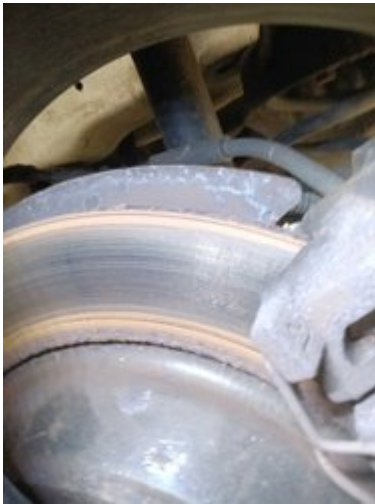
✓ **3. BRAKES:** Rear Brake Disc (Both)

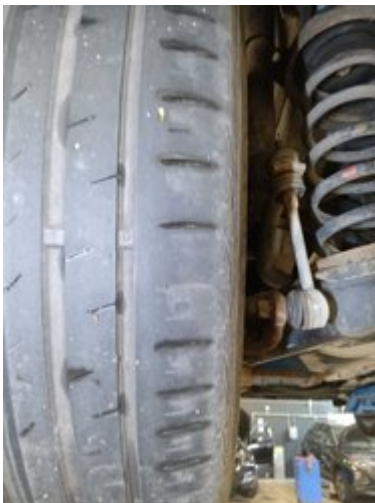
✓ **4. OTHER:** Change Tires

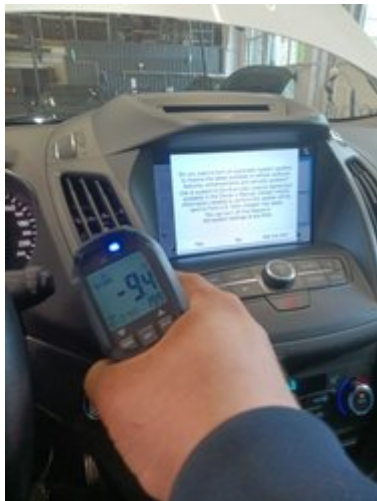
✓ **5. AIR CONDITIONING AND HEATING:** System Evacuation/Recharging

- ✓ 1. System Evacuation/Recharging
- ✓ 2. Other: Engine Mount
- ✓ 3. Change Bulb for License Plate Lights

- 1. Refrigerant R1234YF (R1234YF)
- 2. Engine Mounting (RH11-4060)
