# Diagnosis report of 2018 BMW X3

# Preparation and repair report of 2018 BMW X3

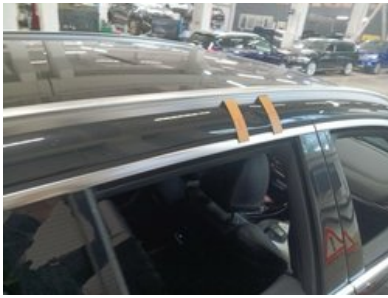
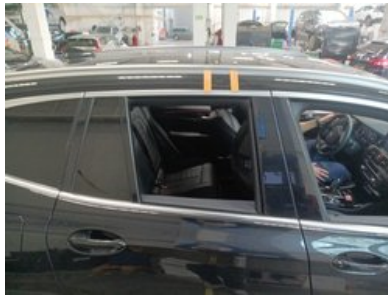
- ✓ **1. Side:** Left and Right Side - Visual Damage and Scratches

- ✓ 1. Paintless Dent Repair

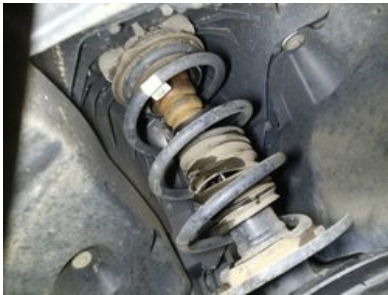
- ✓ **1. OTHER:** Engine Oil & Filter Change
- ✓ **2. SUSPENSION:** Strut Top Mounting (Both)

- ✓ 1. Engine Oil & Filter Change
