# Diagnosis report of 2017 SKODA SUPERB Laurin & Klement

## Summary of diagnosed issues

# Preparation and repair report of 2017 SKODA SUPERB Laurin & Klement

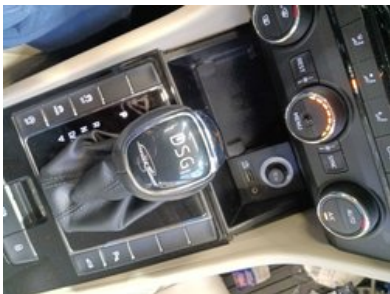
- ✔ 1. Inside: Gear Shift Boot and Gear Shift Knob - Condition

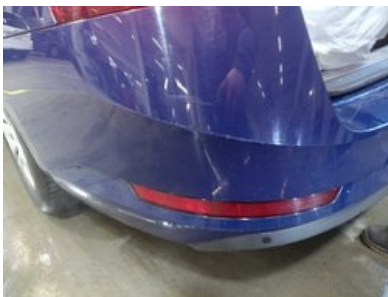
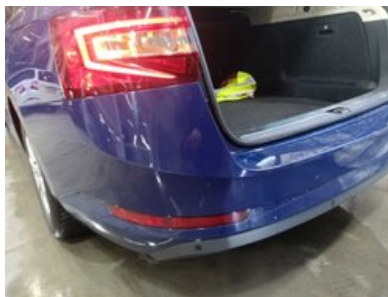
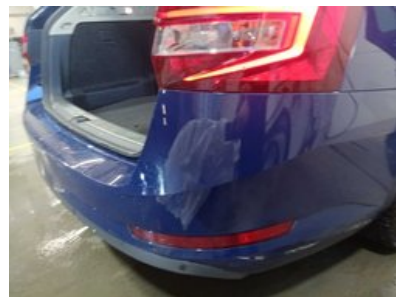
- ✓ **2. Rear:** Rear Bumper - Condition and Alignment

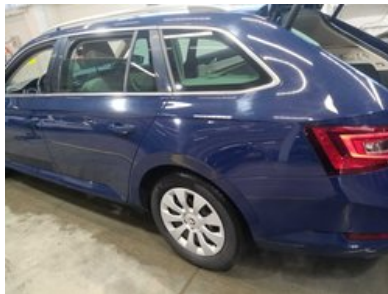
- ✓ **3. Other:** Additional Polishing Tasks

- ✓ 1. Body wet wash
- ✓ 2. Full interior deep clean using only hypoallergenic cleaning products
- ✓ 3. Post cleaning body polish

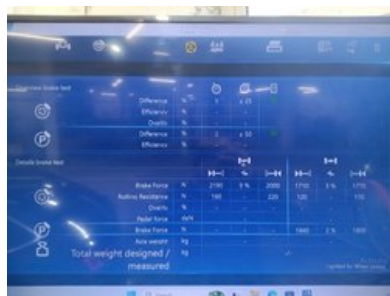
## ✓ 2. Brake Test Line Results

Diagnostic software interface showing brake test results. The screen displays various parameters and their values, including Brake Force, Braking Resistance, and Total weight designed / measured.

| Parameter | Value | Unit | Limit |
| Brake Force | 2750 | N | 2000 |
| Braking Resistance | 180 | % | 220 |
| Total weight designed / measured | 1500 | kg | 1500 |

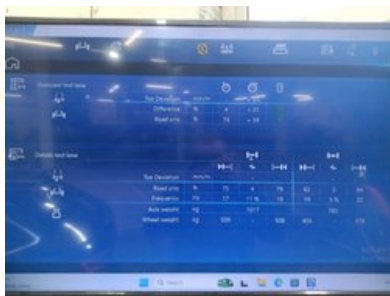
Diagnostic software interface showing brake test results. The screen displays various parameters and their values, including Brake Force, Braking Resistance, and Total weight designed / measured.

| Parameter | Value | Unit | Limit |
| Brake Force | 2750 | N | 2000 |
| Braking Resistance | 180 | % | 220 |
| Total weight designed / measured | 1500 | kg | 1500 |
