Diagnosis report of
2019 OPEL GRANDLAND X Business Exe

Summary of diagnosed issues

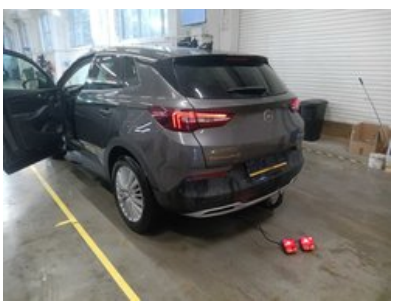
1. Brake Test Line Results
