Diagnosis report of

2014 TOYOTA AURIS

Stock ID: N625265

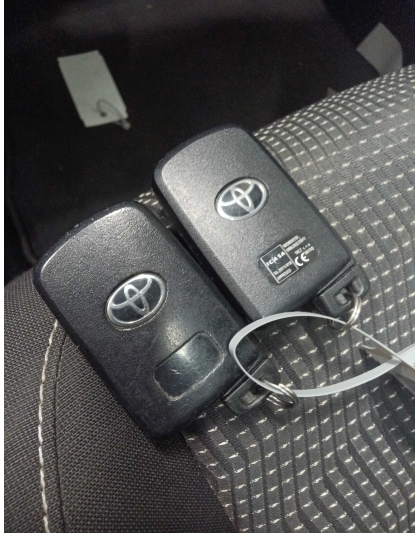
4. INSIDE: Accessories - functioning & condition
