Diagnosis report of
2017 PEUGEOT 2008 Blue Lion

Preparation and repair report of
2017 PEUGEOT 2008 Blue Lion

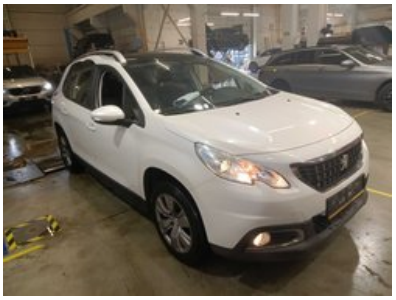
3. ENGINE: Camshaft Drive Belt

- 1. Engine Oil & Filter Change
- 2. Camshaft Drive Belt
