Diagnosis report of
2017 BMW 220 Active Tourer High Execu

Preparation and repair report of
2017 BMW 220 Active Tourer High Execu

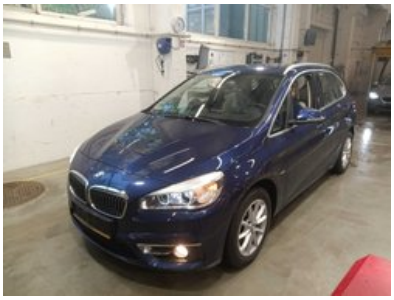
2. OTHER: Engine Oil & Filter Change

1. Spark Plugs
2. Right Engine Bay Mounting
3. Change Front Wiper (Mechanical)
4. Engine Oil & Filter Change

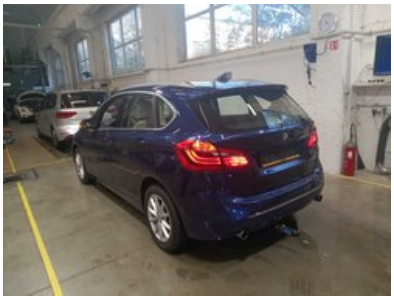
3. ENGINE MANAGEMENT - IGNITION: Spark Plugs
