Diagnosis report of
2019 SKODA OCTAVIA Sport Business

Preparation and repair report of
2019 SKODA OCTAVIA Sport Business

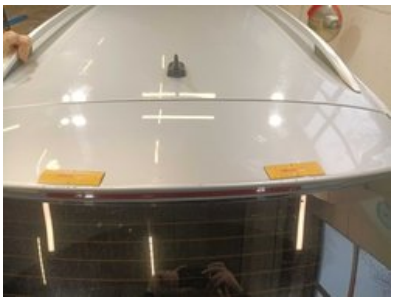
1. Other: Additional Polishing Tasks

2. Rear: Rear Bumper - Condition and Alignment

3. Rear: Trunk - Visual Damage

4. Side: Left and Right Side - Visual Damage and Scratches

5. Side: Left and Right Side - Visual Damage and Scratches

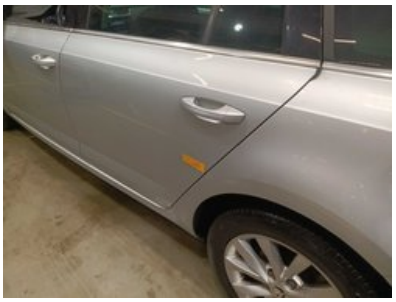
6. Side: Left and Right Side - Visual Damage and Scratches
