Diagnosis report of
2015 TOYOTA VERSO Skyview

Diagnosis details

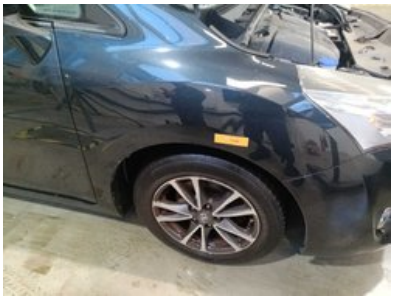
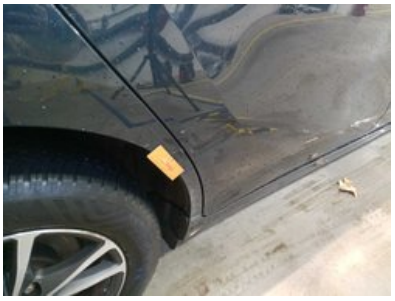
3. Side: Wheels - Condition

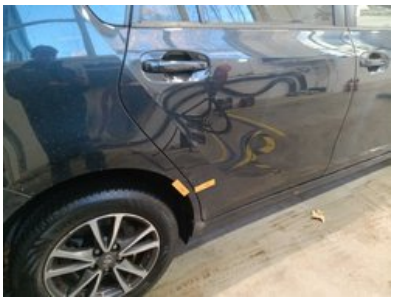
5. Side: Left and Right Side - Visual Damage and Scratches

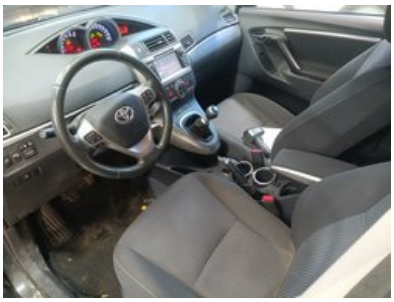
3. Air-Conditioning Measurement
