Diagnosis report of
2017 VOLKSWAGEN PASSAT B8 Highline

Preparation and repair report of
2017 VOLKSWAGEN PASSAT B8 Highline

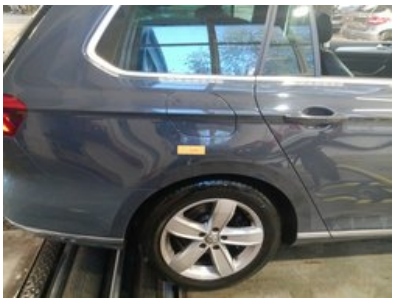
1. Side: Left and Right Side - Visual Damage and Scratches

2. Side: Left and Right Side - Visual Damage and Scratches

3. Front: Hood - Visual Damage

4. Front: Front Bumper - Condition and Alignment

- 1. Paint Hood
