Diagnosis report of
2020 OPEL GRANDLAND X Business Edit

Preparation and repair report of
2020 OPEL GRANDLAND X Business Edit

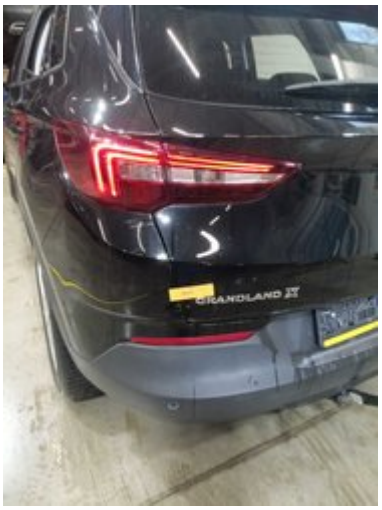
4. Side: Left and Right Side - Visual Damage and Scratches

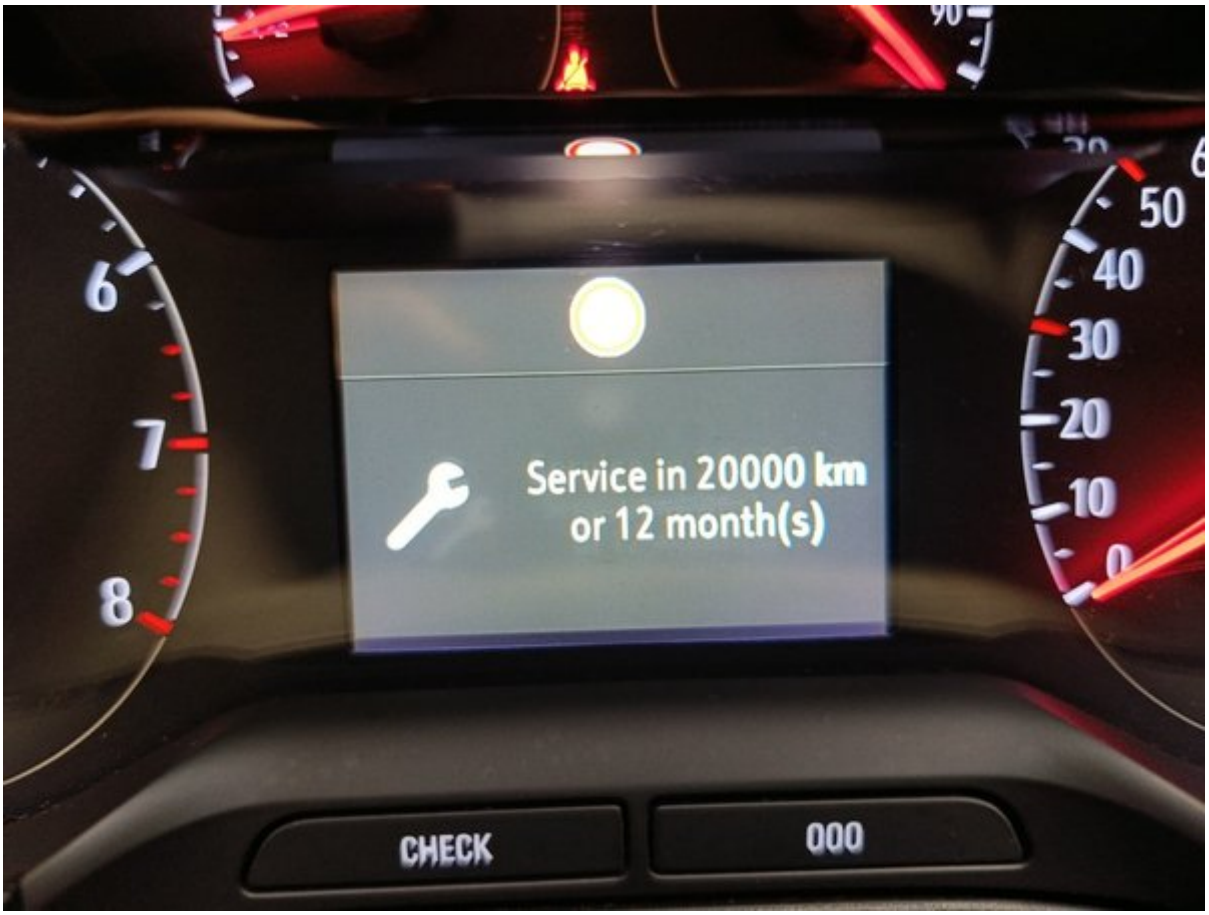
0 km/h
165156 km
0.3 km
CHECK
