# Diagnosis report of
# 2015 AUDI A6 ALLROAD Premium Editio

## Diagnosis details

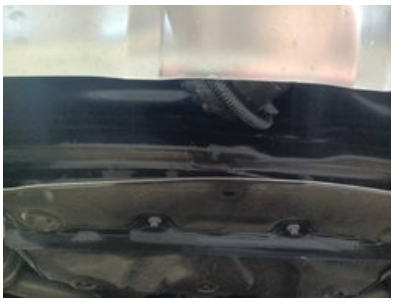
**8. Rear:** Tow Hitch (Attachment, Removal Mechanism, External Light Connector, Connector Thickness)
