Diagnosis report of
2020 OPEL ASTRA Elegance

Preparation and repair report of
2020 OPEL ASTRA Elegance

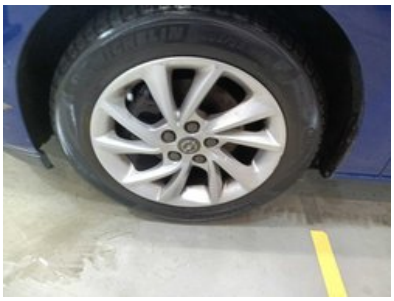
1. Side: Wheels - Condition

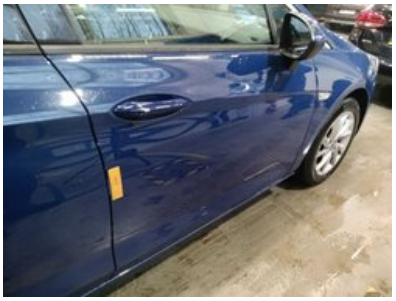
2. Side: Left and Right Side - Visual Damage and Scratches

3. Side: Left and Right Side - Visual Damage and Scratches

4. Side: Left and Right Side - Visual Damage and Scratches
