Diagnosis report of
2016 VOLKSWAGEN PASSAT B8 Business

Diagnosis report of
2016 VOLKSWAGEN PASSAT B8 Busines:

Diagnosis details

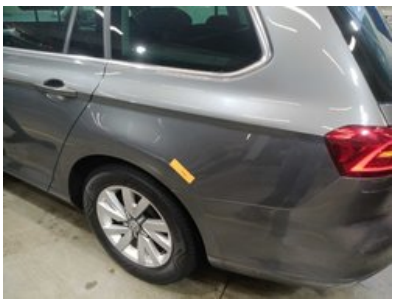
1. Front: Front Bumper - Condition and Alignment

2. Other: Roof - Visual Damage (e.g., Hail Damage)

3. Rear: Rear Bumper - Condition and Alignment

4. Side: Left and Right Side - Visual Damage and Scratches

5. Side: Left and Right Side - Visual Damage and Scratches

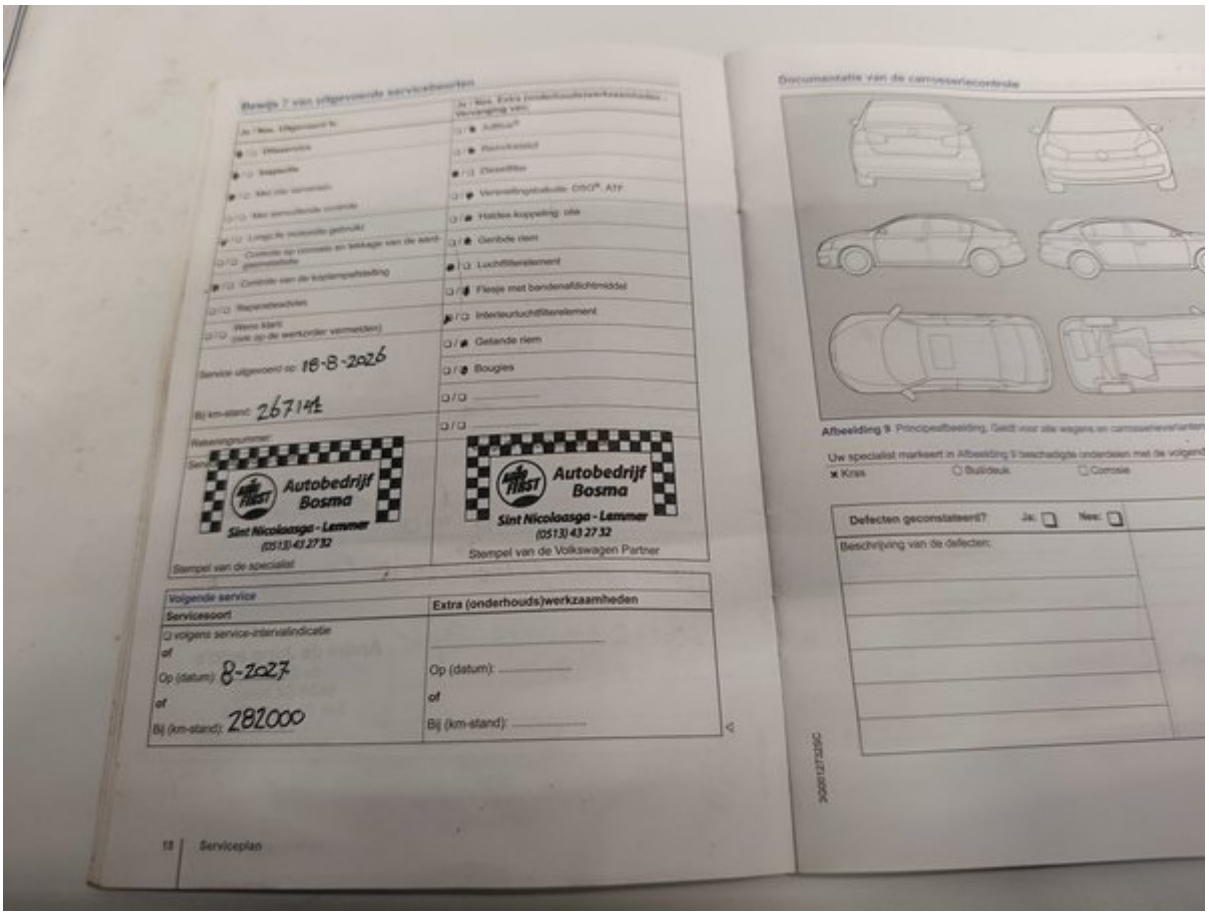
Service uitgevoerd op: 18-8-2026
Bij km-stand: 267141
Autobedrijf Bosma
Sint Nicolaasga - Lemmer
(0513) 43 27 32
Stempel van de Volkswagen Partner
Volgende service
Servicesoort
Extra (onderhouds)werkzaamheden
volgens service-intervalindicatie
of
Op (datum): 8-2027
of
Bij (km-stand): 282000
Op (datum):
of
Bij (km-stand):
Documentatie van de carrosseriecontrole
Afbeelding 9
Uw specialist markeert in Afbeelding 9 beschadigde onderdelen met de volgend
Kras
Buildeuk
Corrosie
Defecten geconstateerd?
Ja:
Nee:
Beschrijving van de defecten:
18
Serviceplan

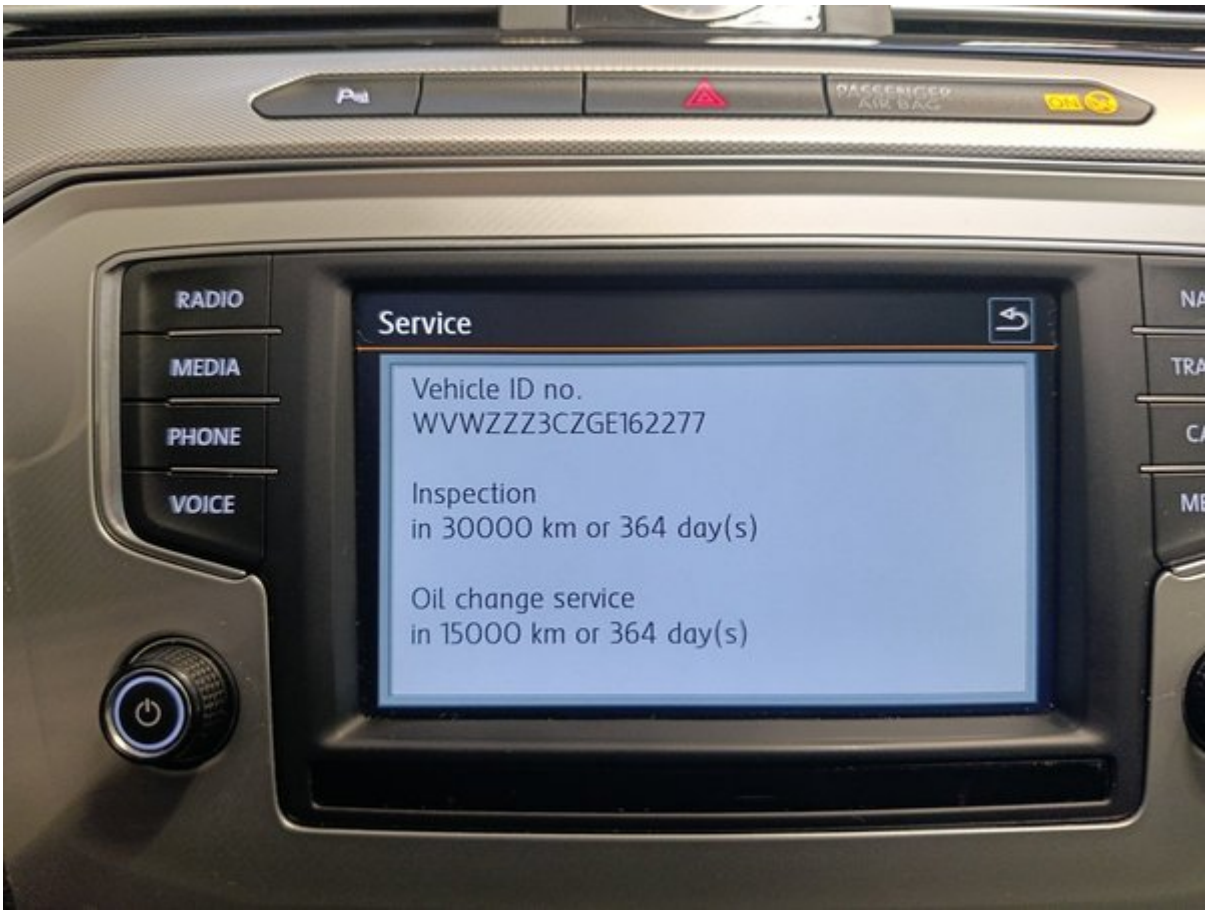
RADIO
MEDIA
PHONE
VOICE
Service
Vehicle ID no.
WVWZZZ3CZGE162277
Inspection
in 30000 km or 364 day(s)
Oil change service
in 15000 km or 364 day(s)
