Diagnosis report of
2023 VOLKSWAGEN TIGUAN Life Busine

Preparation and repair report of
2023 VOLKSWAGEN TIGUAN Life Busine

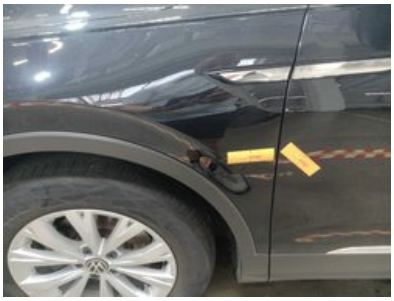
1. Front: Front Bumper - Condition and Alignment

2. Lights: Rear Lights (Brake, Fog, Indicator) - Basic Functioning, Damage, and Color

3. Side: Left and Right Side - Visual Damage and Scratches

- 1. Change Rear Lights

- 1. Paint Door
- 2. Paint Front Fender

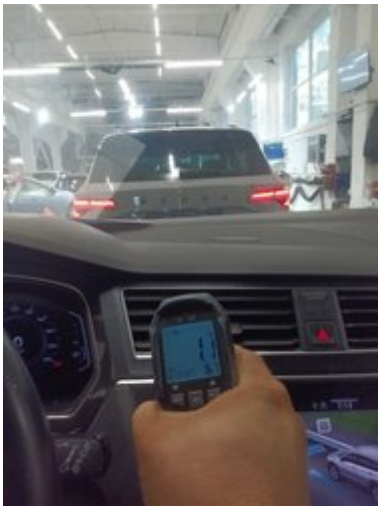
2. Brake Test Line Results
