# Diagnosis report of 2016 VOLKSWAGEN GOLF SPORTSVAN

Diagnosis report of

2016 VOLKSWAGEN GOLF SPORTSVAN

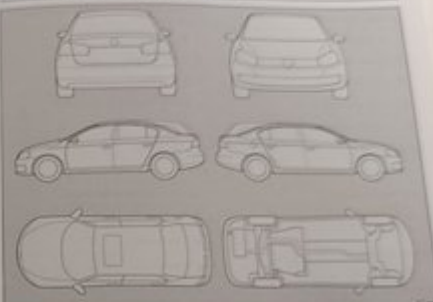
**Afbeelding 5** Principaafbeelding. Geef voor alle wagens en carrosserievarianten een specifiek markeren van de beschadigde onderdelen met de volgende aanduidingen:

☒ Kras ☐ Buitenspiegel ☐ Corrosie ☐ Vervangingsbeurt
