# Diagnosis report of

## 2015 VOLVO XC90 Inscription

# Diagnosis report of 2015 VOLVO XC90 Inscription

## Diagnosis details

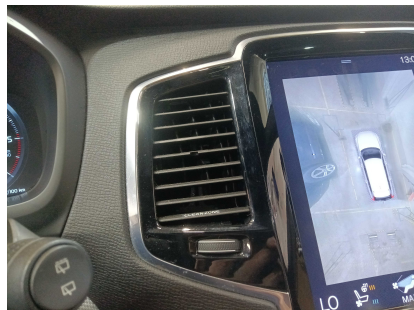
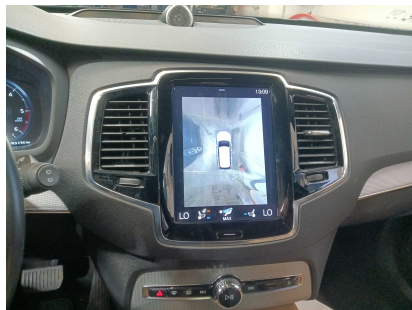
### 1. FRONT: Trims - condition

- ✓ Change airgrille

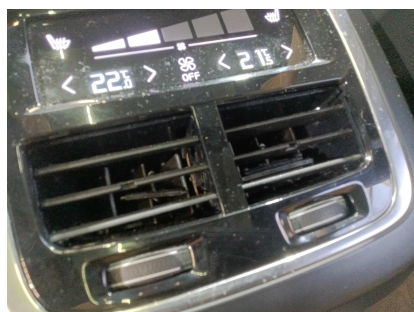
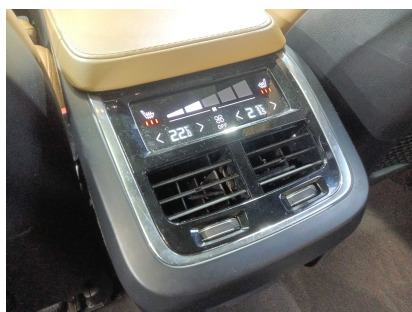
### 2. INSIDE: Trims - condition

- ✓ Change airgrille

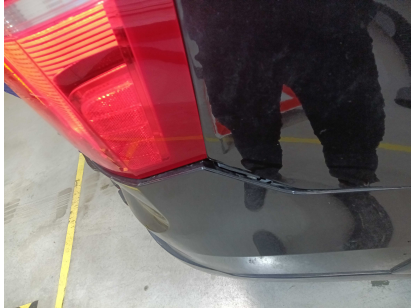
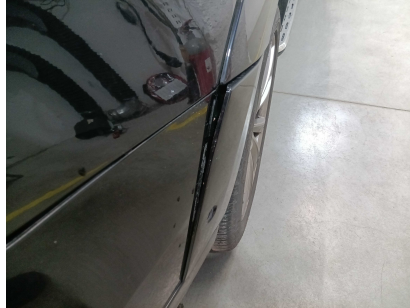
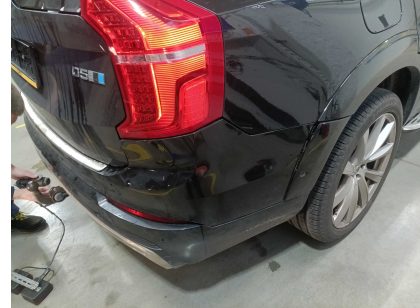
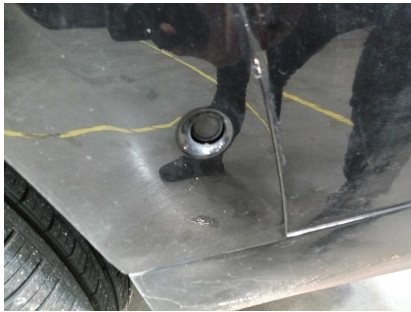
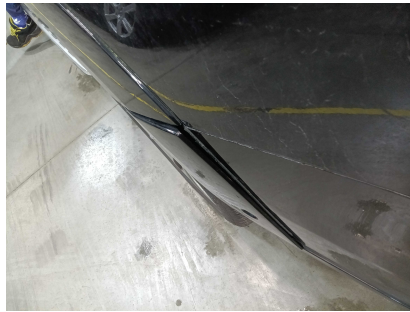
### 3. REAR: Rear bumper - condition and alignment

- ✓ Repair rear bumper corners

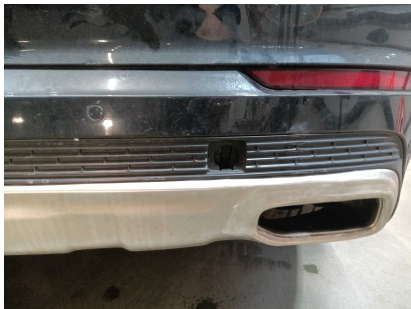
### 4. REAR: Rear bumper - condition and alignment

- ✓ Tow hook cover

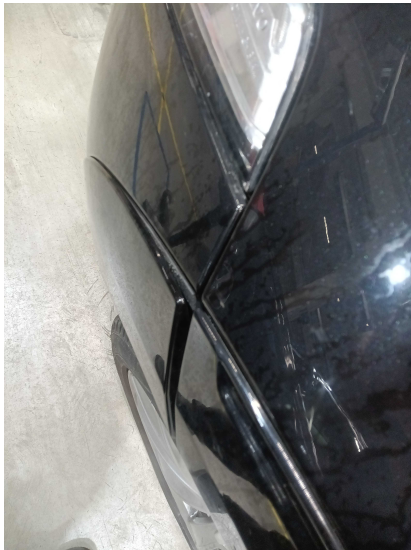
### 5. FRONT: Front bumper - condition and alignment

- ✓ Repair front bumper corner

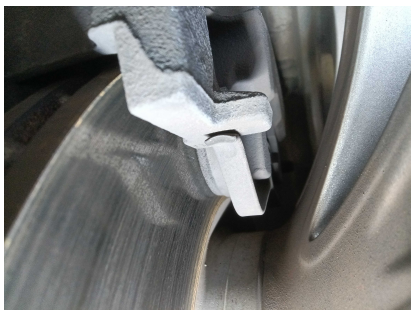
### 4. BRAKES:

- ✔ Front brake pads (all) - wheels removed

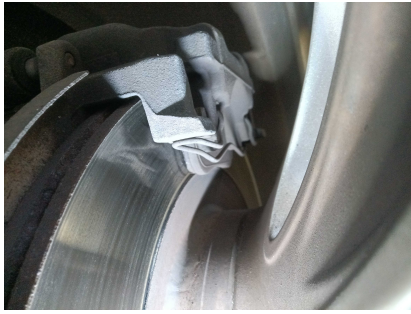
### 5. BRAKES:

- ✔ Rear brake pads (all)

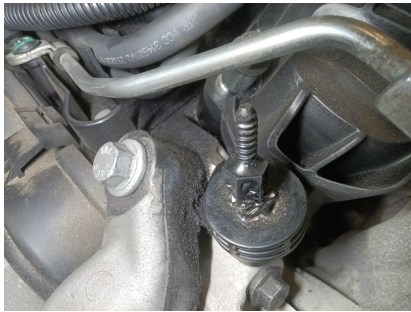
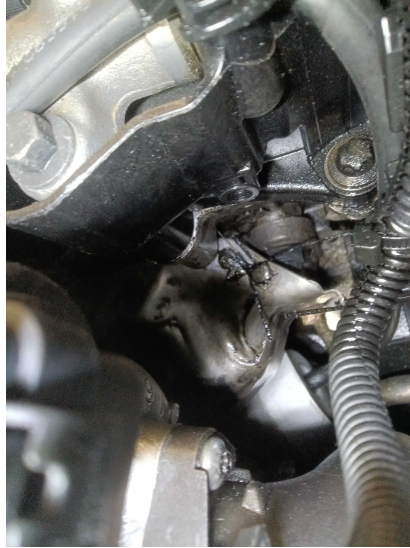
#### 6. ENGINE:

- ✓ Camshaft/valve cover & gasket

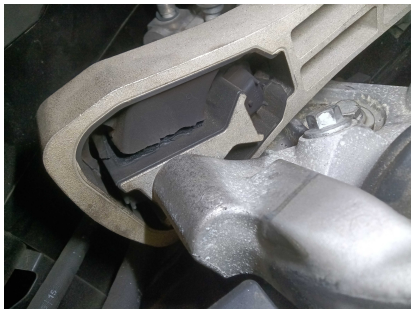
#### 7. ENGINE:

- ✓ Mounting - left (of engine bay)

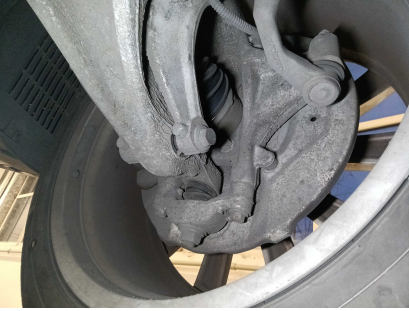
## 9. SUSPENSION:

- ✔ Suspension lower arm

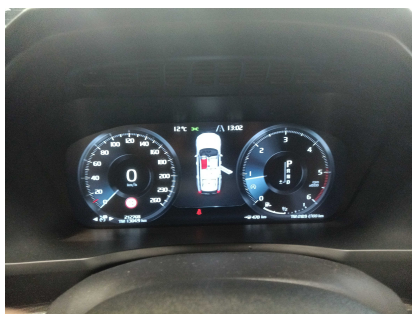
### 2. INSIDE: Accessories - functioning & condition

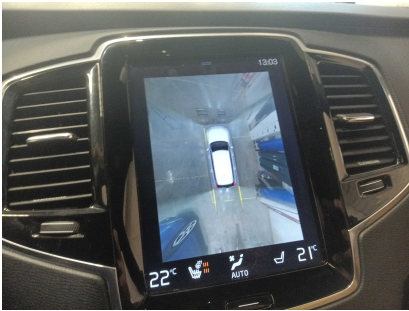
### 3. INSIDE: Accessories - functioning & condition

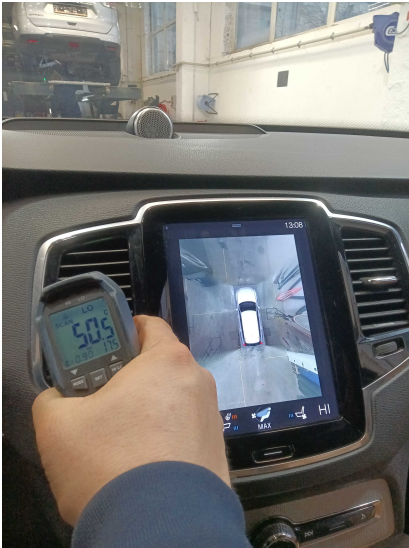
**4. INSIDE:** Accessories - functioning & condition

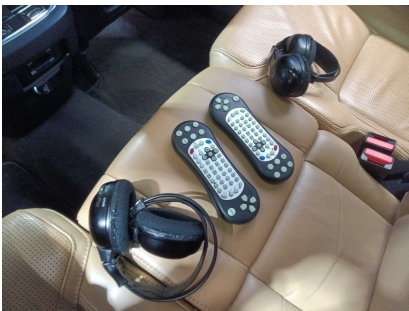
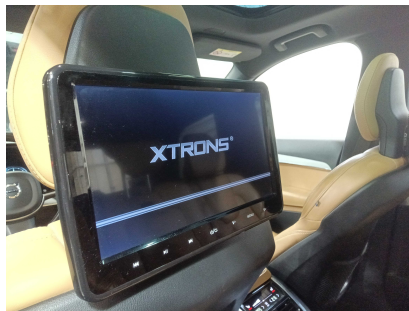
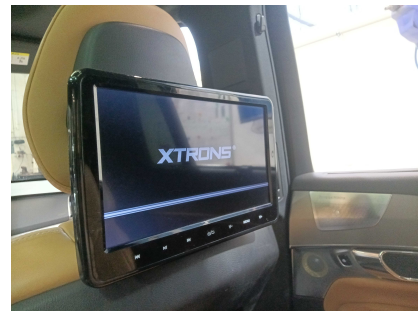
**5. INSIDE:** Accessories - functioning & condition

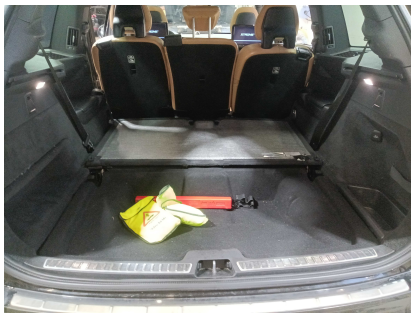
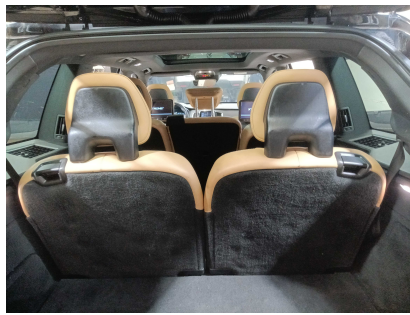
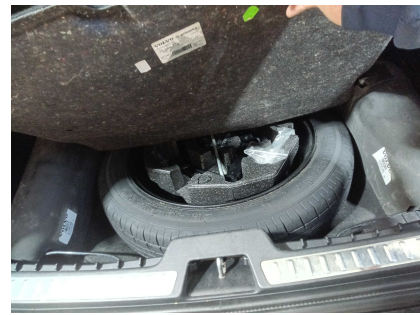
**6. INSIDE:** Accessories - functioning & condition

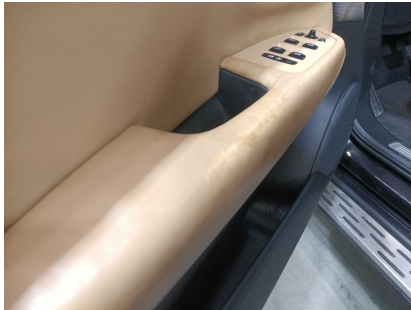
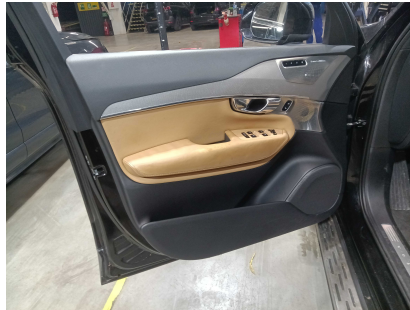
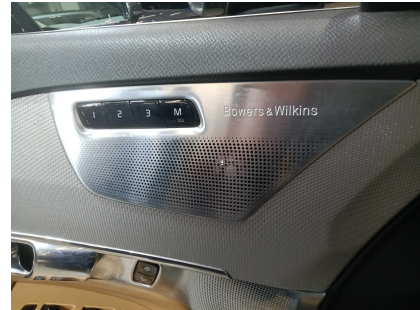
## 7. DOORS: Trims - condition

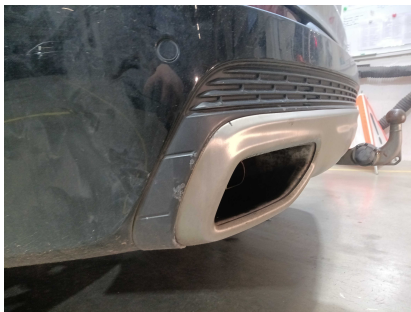
### 1. REAR: Rear bumper - condition and alignment

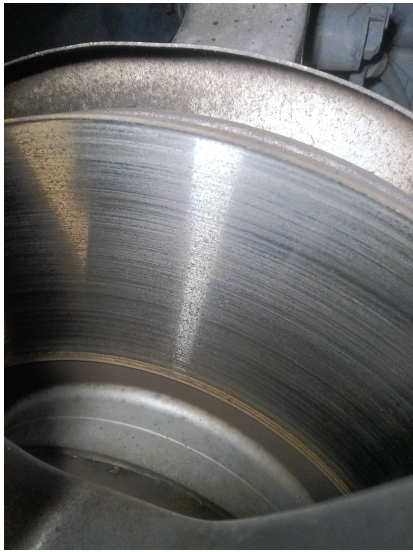
### 1. BRAKES: Front brake disc (both)

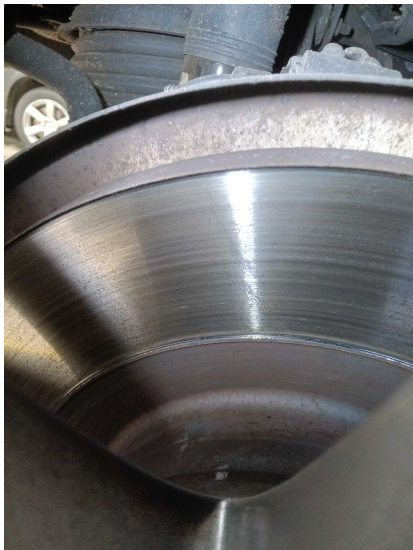
**2. BRAKES:** Rear brake disc (both)
