Diagnosis report of 2015 MITSUBISHI OUTLANDER Business

Diagnosis details

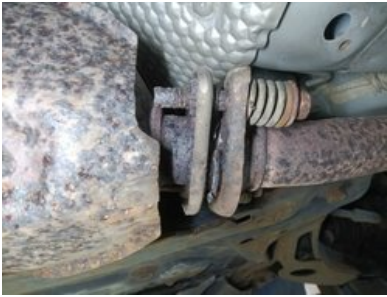
✔ **3. EXHAUST SYSTEM:** Exhaust Connection

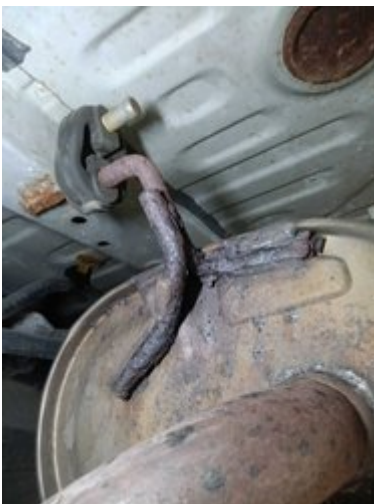
✔ **4. EXHAUST SYSTEM:** Exhaust Mounting

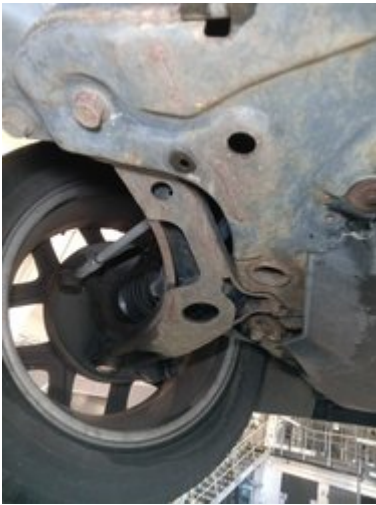
7. BODY - REAR SECTION: Corrosion

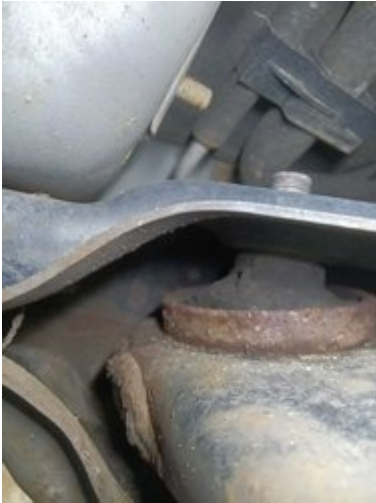
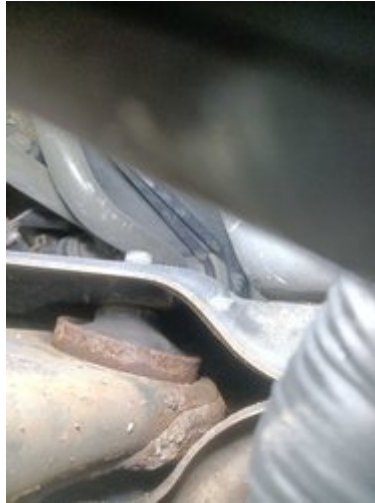
✔ **8. SUSPENSION:** Suspension Lower Arm Bushes Both

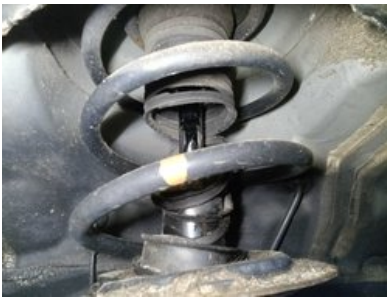
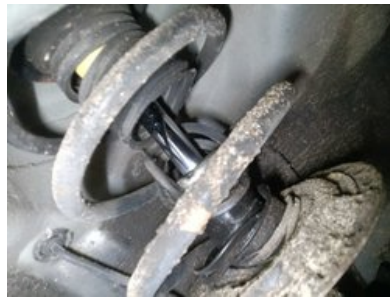
✔ **9. SUSPENSION:** Front Shock Absorber Dust Cover

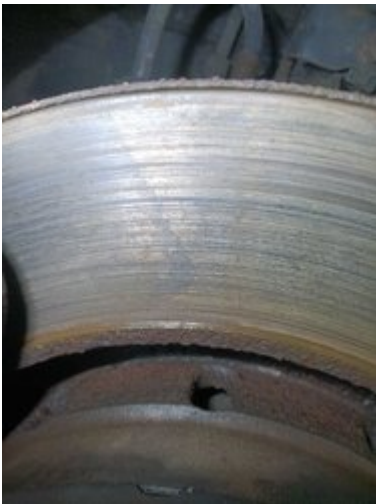
✔ **10. BRAKES:** Front Brake Discs Both

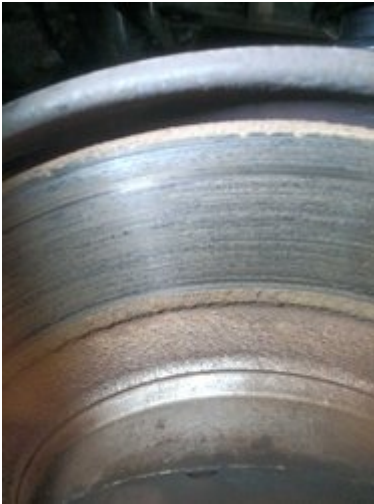
11. BRAKES: Rear Brake Disc (Both)
