# Diagnosis report of 2015 MITSUBISHI OUTLANDER AWD Bu

Diagnosis report of

2015 MITSUBISHI OUTLANDER AWD Bu

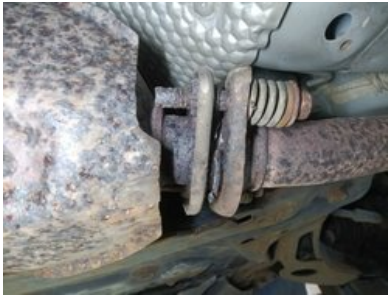
✓ **3. EXHAUST SYSTEM:** Exhaust Connection

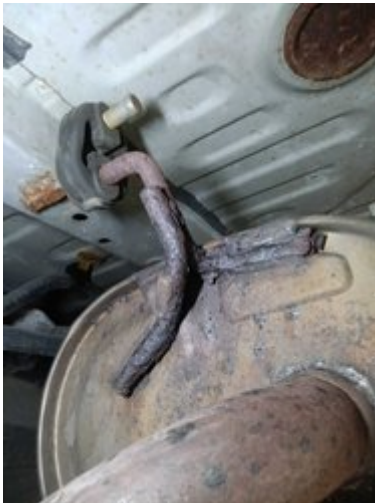
✓ **4. EXHAUST SYSTEM:** Exhaust Mounting

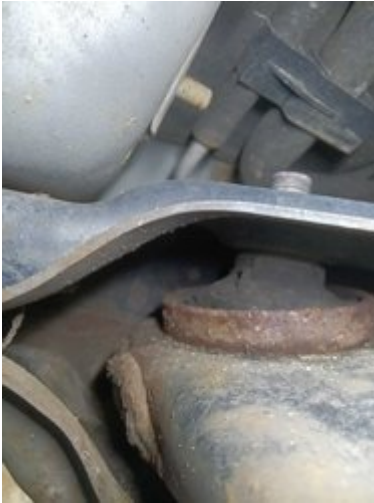
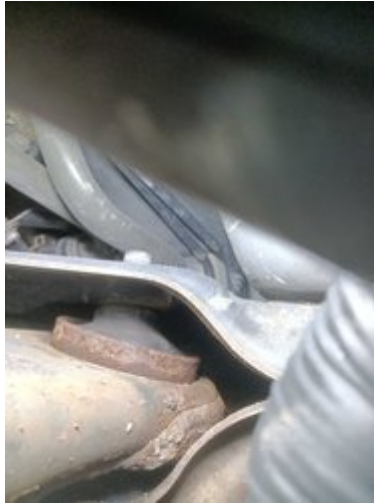
✔ **8. SUSPENSION:** Suspension Lower Arm Bushes Both

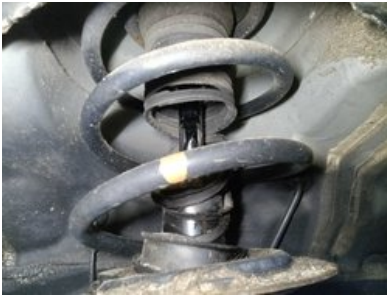
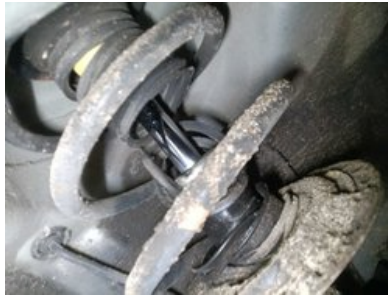
✔ **9. SUSPENSION:** Front Shock Absorber Dust Cover

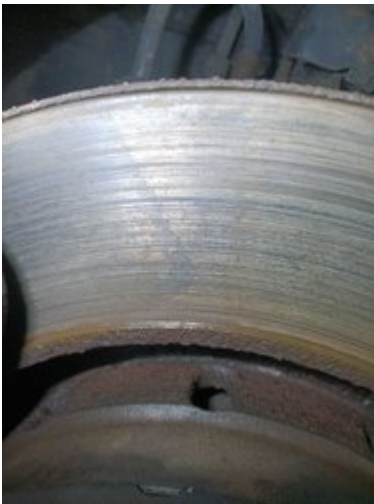
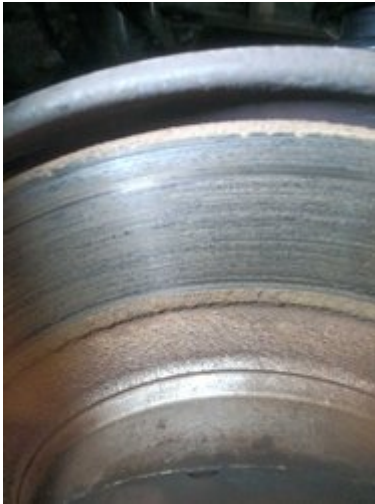
✔ **10. BRAKES:** Front Brake Discs Both

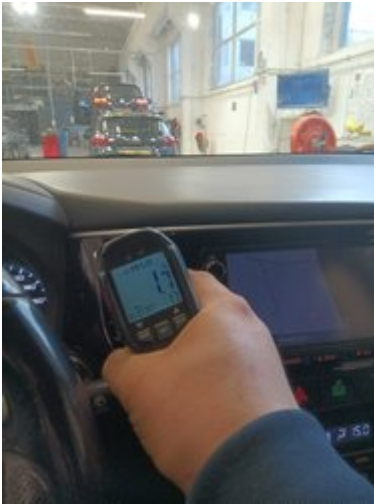
✓ 3. Air-Conditioning Measurement
