# Diagnosis report of 2015 MITSUBISHI OUTLANDER Business

Diagnosis report of

2015 MITSUBISHI OUTLANDER Business

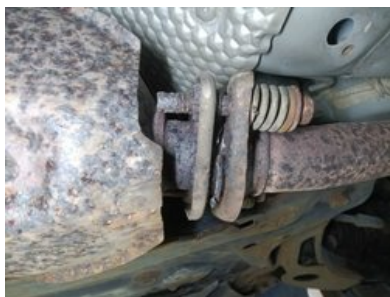
✓ **3. EXHAUST SYSTEM:** Exhaust Connection

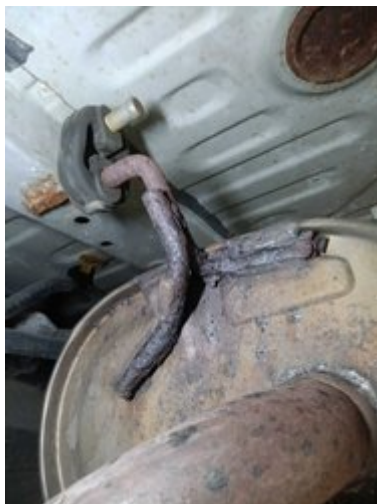
✓ **4. EXHAUST SYSTEM:** Exhaust Mounting

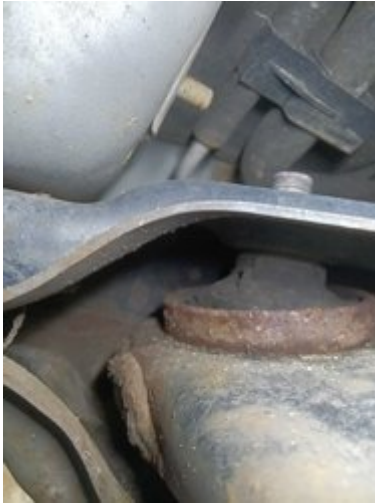
✓ **8. SUSPENSION:** Suspension Lower Arm Bushes Both

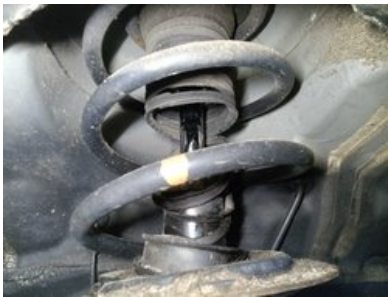
✓ **9. SUSPENSION:** Front Shock Absorber Dust Cover

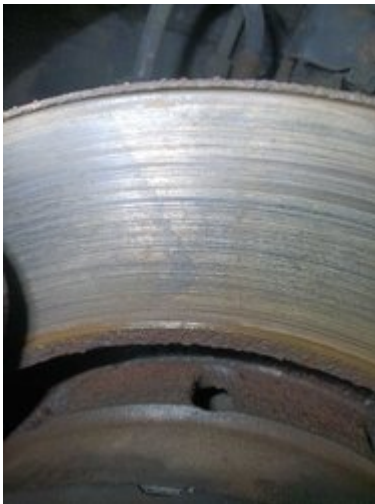
✓ **10. BRAKES:** Front Brake Discs Both

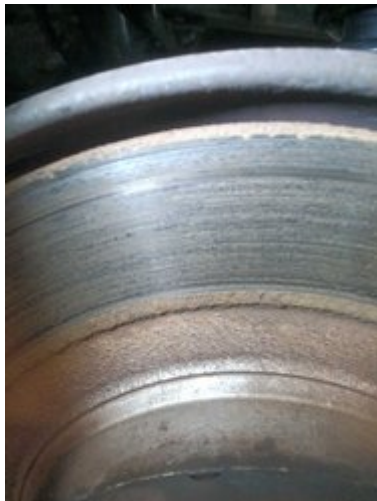
✓ **11. BRAKES:** Rear Brake Disc (Both)
